Access Compliance Report Public Rights-of-Way (Curb Ramps)

Intersection ID: 28536Main Street:SOUTH_STREAM_BVCross Street:W_TYVOLA_RDLocation:NADA ID: E840EF208353Ramp Type:ParaInitial Pass/Fail:FailOverall Compliance:NoSeverity Score:8.75

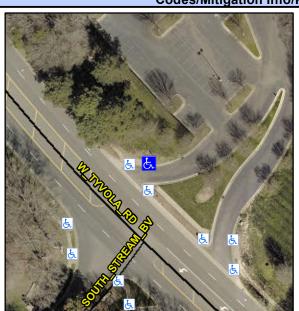
Compliance Description Data Compliance Description Data					
N/A	Ramp Length LT (in)	60.0	N/A	Ramp Length RT (in)	80.0
No	Ramp Width LT (in)	40.0	Yes	Ramp Width RT (in)	60.0
Yes	Ramp Slope LT (%)	1.2	Yes	Ramp Slope RT (%)	3.7
Yes	Ramp XSlope LT (%)	1.0	Yes	Ramp XSlope RT (%)	1.0
N/A	Landing Length (in)	N/A	N/A	DWS Provided?	N/A
N/A	Landing Width (in)	N/A	N/A	DWS Contrast?	N/A
N/A	Landing Slope (%)	N/A	N/A	DWS Length (in)	N/A
N/A	Landing X Slope (%)	N/A	N/A	DWS Full Width?	N/A
N/A	Landing Curb? (Y/N)	N/A	N/A	DWS Offset (in)	N/A
N/A	Shared Landing?	N/A			
N/A	Gutter Ponding?	N/A	N/A	Gutter Slope (%)	N/A
N/A	Gutter Lip Ht (in)	N/A	N/A	Gutter X Slope (%)	N/A
N/A	Painted X Walk1?	No	N/A	Painted X Walk2?	N/A
	X Walk 1 Direction	To S		X Walk 2 Direction	N/A
N/A	X Walk 1 Width (in)	N/A	N/A	X Walk 2 Width (in)	N/A
	X Walk 1 Slope (%)	1.3		X Walk 2 Slope (%)	N/A
	X Walk 1 X Slope (%)	1.0		X Walk 2 X Slope (%)	N/A
N/A	Ramp inside XWalk1?	N/A	N/A	Ramp inside XWalk2?	N/A

Road Slope (%)	N/A	N/A	Clear Space?	N/A
	Road X Slope (%)	N/A	N/A	Clear Space to XWalk (in)	N/A
N/A	Any Obstructions?	N/A	N/A	Storm Grate/Utility Hazard?	N/A
	Obstruction Type			Storm Grate/Utility Type	
		N/A			N/A
			Yes	Surface Condition? (G/P)	Good
			Replace Curb Siloppe (%)		10.5
	<u> </u>

Total Cost: \$ 1600.00
