Access Compliance Report

Public Rights-of-Way

(Curb Ramps)

Intersection ID: 27538	Main Street: ALTON_FARM_LN	Cross Street: CHARLOTTE_VIEW_DR	Location: SE
ADA ID: E845D4C6BF0A	Ramp Type: PerpDiag	Initial Pass/Fail: Fail	Overall Compliance: No
Severity Score: 25			
Codes/Mitigation Info/Possible Solution		Field Measurements/Component Compliance

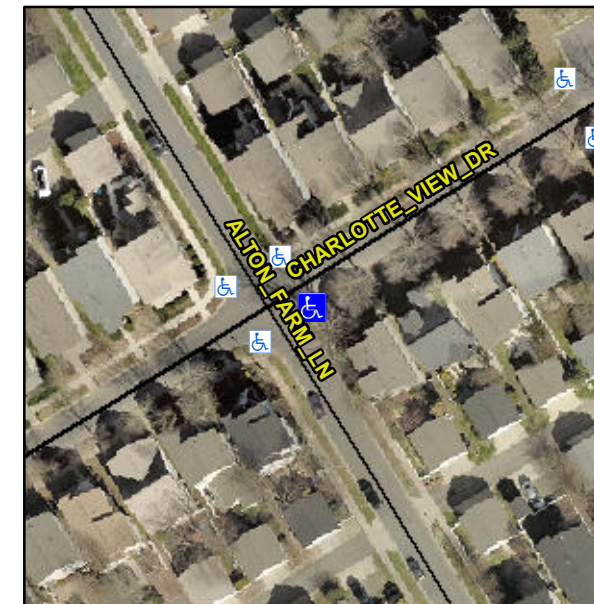
Compliance	Description	Data	Compliance	Description	Data
N/A	Ramp Length (in)	48.0	No	Ramp Slope (%)	19.3
Yes	Ramp Width (in)	48.0	Yes	Ramp XSlope (%)	1.0
N/A	Flare Type LT	N/A	N/A	Flare Type RT	N/A
N/A	Flare Slope LT (%)	N/A	N/A	Flare Slope RT (%)	N/A
N/A	Flare Traversable LT?	N/A	N/A	Flare Traversable RT?	N/A
N/A	Landing Length (in)	N/A	N/A	DWS Provided?	N/A
N/A	Landing Width (in)	N/A	N/A	DWS Contrast?	N/A
N/A	Landing Slope (%)	N/A	N/A	DWS Length (in)	N/A
N/A	Landing X Slope (%)	N/A	N/A	DWS Full Width?	N/A
N/A	Landing Curb? (Y/N)	N/A	N/A	DWS Offset (in)	N/A
N/A	Shared Landing?	N/A			
N/A	Gutter Ponding?	N/A	N/A	Gutter Slope (%)	N/A
N/A	Gutter Lip Ht (in)	N/A	N/A	Gutter X Slope (%)	N/A
N/A	Painted X Walk1?	No	N/A	Painted X Walk2?	No
	X Walk 1 Direction	To NW		X Walk 2 Direction	To SW
N/A	X Walk 1 Width (in)	N/A	N/A	X Walk 2 Width (in)	N/A
	X Walk 1 Slope (%)	0.1		X Walk 2 Slope (%)	0.2
	X Walk 1 X Slope (%)	1.6		X Walk 2 X Slope (%)	1.7

N/A	Ramp inside XWalk1?	N/A	N/A	Ramp inside XWalk2?	N/A
	Road Slope (%)	1.3	N/A	Clear Space?	N/A
	Road X Slope (%)	0.4	N/A	Clear Space to XWalk (in)	N/A
N/A	Any Obstructions?	N/A	N/A	Storm Grate/Utility Hazard?	N/A
	Obstruction Type			Storm Grate/Utility Type	
		N/A			N/A
			Yes	Surface Condition? (G/P)	Good

Possible Solutions:

Remove & Replace Curb Ramp With Two New Directional Ramps or Equivalent.
