Access Compliance Report

Public Rights-of-Way

(Curb Ramps)

Intersection ID: N/A	Main Street: YANCEY_RD	Cross Street: SOUTHSIDE_DR	Location: E
ADA ID: E849A805F04B	Ramp Type: PerpDiag	Initial Pass/Fail: Fail	Overall Compliance: No
		Severity Score: 22.5

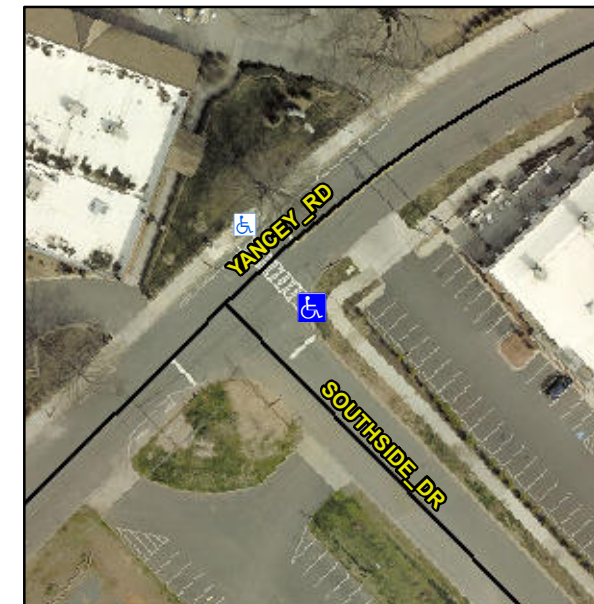
Not Found, R304.5.1, R304.2.2, R304.5.3

Compliance	Description	Data	Compliance	Description	Data
N/A	Ramp Length (in)	91.0	No	Ramp Slope (%)	11.0
No	Ramp Width (in)	44.0	No	Ramp XSlope (%)	4.2
N/A	Flare Type LT	N/A	N/A	Flare Type RT	N/A
N/A	Flare Slope LT (%)	N/A	N/A	Flare Slope RT (%)	N/A
N/A	Flare Traversable LT?	N/A	N/A	Flare Traversable RT?	N/A
N/A	Landing Length (in)	N/A	N/A	DWS Provided?	N/A
N/A	Landing Width (in)	N/A	N/A	DWS Contrast?	N/A
N/A	Landing Slope (%)	N/A	N/A	DWS Length (in)	N/A
N/A	Landing X Slope (%)	N/A	N/A	DWS Full Width?	N/A
N/A	Landing Curb? (Y/N)	N/A	N/A	DWS Offset (in)	N/A
N/A	Shared Landing?	N/A			
N/A	Gutter Ponding?	N/A	N/A	Gutter Slope (%)	N/A
N/A	Gutter Lip Ht (in)	N/A	N/A	Gutter X Slope (%)	N/A
N/A	Painted X Walk1?	No	N/A	Painted X Walk2?	No
	X Walk 1 Direction	To SW		X Walk 2 Direction	To NW
N/A	X Walk 1 Width (in)	N/A	N/A	X Walk 2 Width (in)	N/A
	X Walk 1 Slope (%)	8.5		X Walk 2 Slope (%)	0.7
	X Walk 1 X Slope (%)	0.7		X Walk 2 X Slope (%)	4.7

N/A	Ramp inside XWalk1?	N/A	N/A	Ramp inside XWalk2?	N/A
	Road Slope (%)	3.8	N/A	Clear Space?	N/A
	Road X Slope (%)	3.3	N/A	Clear Space to XWalk (in)	N/A
N/A	Any Obstructions?	N/A	N/A	Storm Grate/Utility Hazard?	N/A
	Obstruction Type			Storm Grate/Utility Type	
		N/A			N/A
			Yes	Surface Condition? (G/P)	Good

Remove & Replace Curb Ramp With Two New Directional Ramps or Equivalent.
