# Access Compliance Report

## Public Rights-of-Way

### (Curb Ramps)

Intersection ID: 44239	Main Street: SELARI_CT	Cross Street: CHIEFTAIN_DR	Location: S
ADA ID: E855F40E4FCA	Ramp Type: Perp	Initial Pass/Fail: Fail	Overall Compliance: No
Severity Score: 8.75			
Codes/Mitigation Info/Possible Solution		Field Measurements/Component Compliance

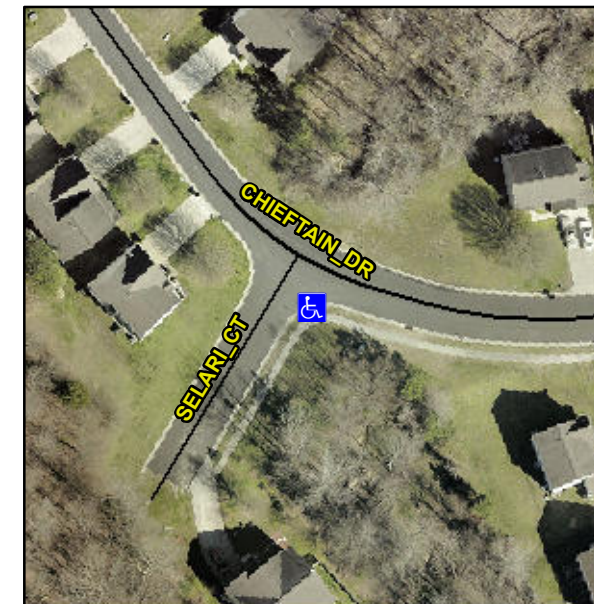
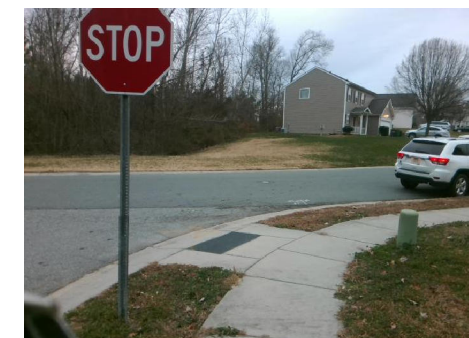
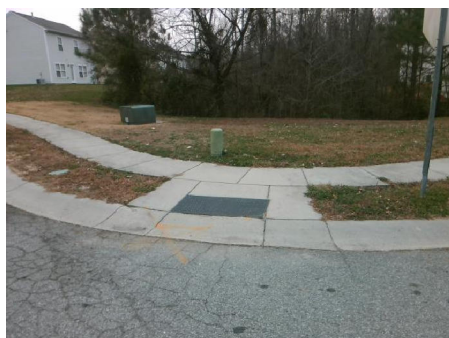
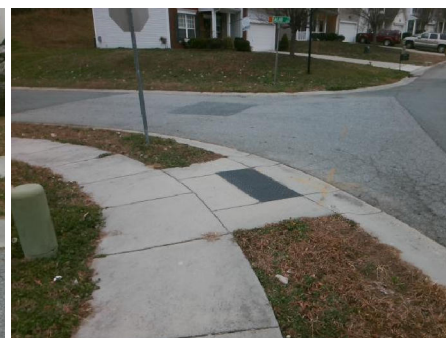
**Not Found, R304.5.1**

Compliance	Description	Data	Compliance	Description	Data
N/A	Ramp Length (in)	49.0	Yes	Ramp Slope (%)	6.2
No	Ramp Width (in)	44.0	Yes	Ramp XSlope (%)	0.4
N/A	Flare Type LT	N/A	N/A	Flare Type RT	N/A
N/A	Flare Slope LT (%)	N/A	N/A	Flare Slope RT (%)	N/A
N/A	Flare Traversable LT?	N/A	N/A	Flare Traversable RT?	N/A
N/A	Landing Length (in)	N/A	N/A	DWS Provided?	N/A
N/A	Landing Width (in)	N/A	N/A	DWS Contrast?	N/A
N/A	Landing Slope (%)	N/A	N/A	DWS Length (in)	N/A
N/A	Landing X Slope (%)	N/A	N/A	DWS Full Width?	N/A
N/A	Landing Curb? (Y/N)	N/A	N/A	DWS Offset (in)	N/A
N/A	Shared Landing?	N/A			
N/A	Gutter Ponding?	N/A	N/A	Gutter Slope (%)	N/A
N/A	Gutter Lip Ht (in)	N/A	N/A	Gutter X Slope (%)	N/A
N/A	Painted X Walk1?	No	N/A	Painted X Walk2?	N/A
	X Walk 1 Direction	To NW		X Walk 2 Direction	N/A
N/A	X Walk 1 Width (in)	N/A	N/A	X Walk 2 Width (in)	N/A
	X Walk 1 Slope (%)	2.5		X Walk 2 Slope (%)	N/A
	X Walk 1 X Slope (%)	0.8		X Walk 2 X Slope (%)	N/A

**Remove & Replace Entire Ramp.**
