## Access Compliance Report Public Rights-of-Way (Curb Ramps)

Intersection ID: 11443 Main Street: MCKELVEY\_ST Cross Street: STONEHAVEN\_DR Location: NE

ADA ID: E8576DDA2164 Ramp Type: BlendTrans1 Initial Pass/Fail: Fail Overall Compliance: No Severity Score: 10

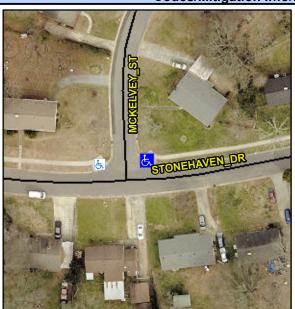
Not Found, R304.5.1, R304.5.3

Compliance Description Data Compliance Description Data Ramp Length (in) Yes N/A 74.0 BlendTrans Slope (%) 3.4 47.0 No No Ramp Width (in) BlendTrans XSlope (%) 3.4 N/A N/A Flare Type LT N/A Flare Type RT N/A N/A Flare Slope LT (%) N/A N/A Flare Slope RT (%) N/A N/A Flare Traversable LT? N/A N/A Flare Traversable RT? N/A N/A Landing Length (in) N/A N/A **DWS Provided?** N/A N/A Landing Width (in) N/A N/A **DWS Contrast?** N/A N/A N/A Landing Slope (%) DWS Length (in) N/A Landing X Slope (%) N/A N/A DWS Full Width? N/A Landing Curb? (Y/N) N/A N/A DWS Offset (in) N/A N/A Shared Landing? **Gutter Ponding?** N/A N/A Gutter Slope (%) N/A Gutter Lip Ht (in) 0.5 N/A Gutter X Slope (%) N/A Painted X Walk1? No N/A Painted X Walk2? N/A X Walk 1 Direction To W X Walk 2 Direction N/A N/A X Walk 1 Width (in) X Walk 2 Width (in) N/A X Walk 1 Slope (%) X Walk 2 Slope (%) N/A 1.4 X Walk 1 X Slope (%) 8.0 X Walk 2 X Slope (%) N/A N/A N/A Ramp inside XWalk2? N/A Ramp inside XWalk1? Road Slope (%) 8.0 Clear Space? N/A N/A Road X Slope (%) Clear Space to XWalk (in) N/A 1.4 N/A N/A Any Obstructions? Storm Grate/Utility Hazard? N/A **Obstruction Type** Storm Grate/Utility Type N/A N/A Yes Surface Condition? (G/P) Good

Remove & Replace Curb Ramp With Two New Directional Ramps or Equivalent.
