Access Compliance Report

Public Rights-of-Way

(Curb Ramps)

Intersection ID: 11278	Main Street: DELGANY_DR	Cross Street: FOXFORD_PL	Location: NW
ADA ID: E860A64E7280	Ramp Type: BlendTrans1	Initial Pass/Fail: Fail	Overall Compliance: No
Codes/Mitigation Info/Possible Solution		Field Measurements/Component Compliance	
Severity Score: 8.75

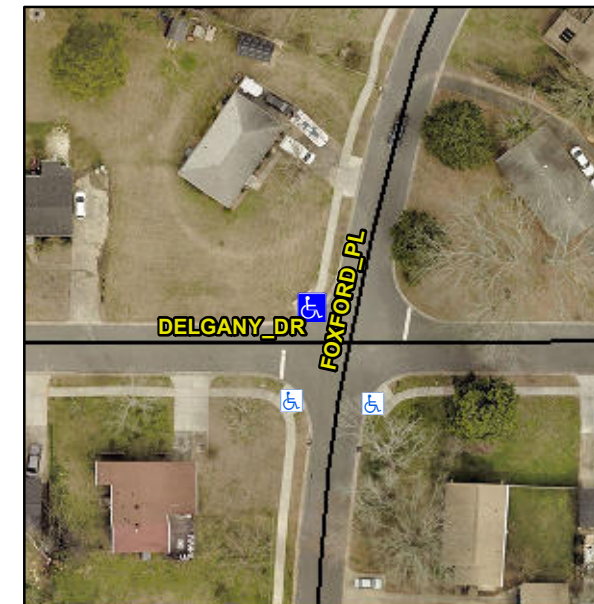
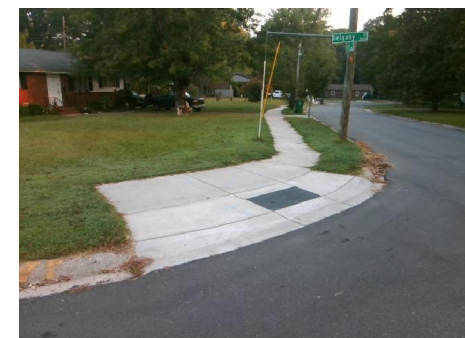
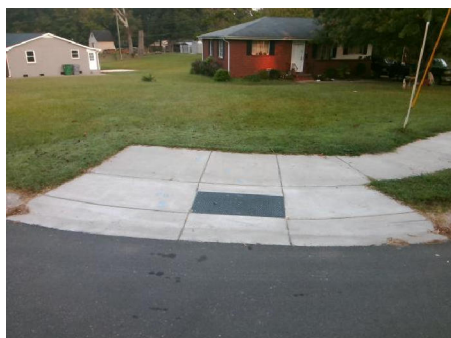
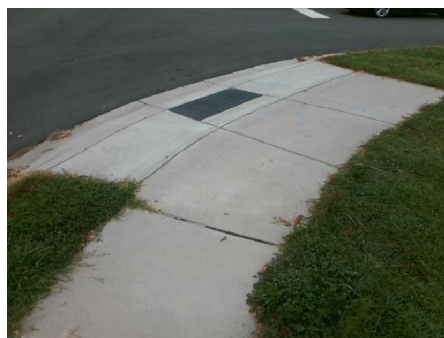
Compliance	Description	Data	Compliance	Description	Data
N/A	Ramp Length (in)	97.5	Yes	BlendTrans Slope (%)	4.6
No	Ramp Width (in)	46.5	Yes	BlendTrans XSlope (%)	1.0
N/A	Flare Type LT	N/A	N/A	Flare Type RT	N/A
N/A	Flare Slope LT (%)	N/A	N/A	Flare Slope RT (%)	N/A
N/A	Flare Traversable LT?	N/A	N/A	Flare Traversable RT?	N/A
N/A	Landing Length (in)	N/A	N/A	DWS Provided?	N/A
N/A	Landing Width (in)	N/A	N/A	DWS Contrast?	N/A
N/A	Landing Slope (%)	N/A	N/A	DWS Length (in)	N/A
N/A	Landing X Slope (%)	N/A	N/A	DWS Full Width?	N/A
N/A	Landing Curb? (Y/N)	N/A	N/A	DWS Offset (in)	N/A
N/A	Shared Landing?	N/A			
N/A	Gutter Ponding?	N/A	N/A	Gutter Slope (%)	N/A
N/A	Gutter Lip Ht (in)	N/A	N/A	Gutter X Slope (%)	N/A
N/A	Painted X Walk1?	No	N/A	Painted X Walk2?	N/A
	X Walk 1 Direction	To S		X Walk 2 Direction	N/A
	X Walk 1 Width (in)	N/A		X Walk 2 Width (in)	N/A
	X Walk 1 Slope (%)	0.7		X Walk 2 Slope (%)	N/A
	X Walk 1 X Slope (%)	2.0		X Walk 2 X Slope (%)	N/A

N/A	Ramp inside XWalk1?	N/A	N/A	Ramp inside XWalk2?	N/A
	Road Slope (%)	2.0		Clear Space?	N/A
	Road X Slope (%)	0.7	N/A	Clear Space to XWalk (in)	N/A
N/A	Any Obstructions?	N/A	N/A	Storm Grate/Utility Hazard?	N/A
	Obstruction Type			Storm Grate/Utility Type	
		N/A			N/A
			Yes	Surface Condition? (G/P)	Good
			No	Curb Slope (%)	15.5

Possible Solutions:

Remove & Replace Curb Ramp With Two New Directional Ramps or Equivalent.

Not Found, R304.5.1
