Access Compliance Report

Public Rights-of-Way

(Curb Ramps)

Intersection ID: 10040935	Main Street: WALLINGFORD_ST	Cross Street: N/A	Location: SW
ADA ID: E8668B85398D	Ramp Type: Perp	Initial Pass/Fail: Fail	Overall Compliance: No
			Severity Score: 26.25

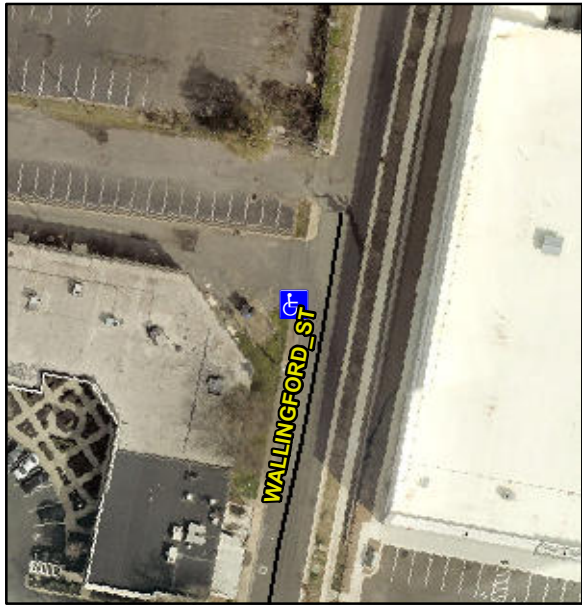
Possible Solutions:		Compliance	Description	Data	Compliance	Description	Data
	Remove & Replace Entire Ramp.		N/A	Ramp Length (in)	44.0	No	Ramp Slope (%)	13.8
			Yes	Ramp Width (in)	50.0	No	Ramp XSlope (%)	3.3
			N/A	Flare Type LT	N/A	N/A	Flare Type RT	N/A
			N/A	Flare Slope LT (%)	N/A	N/A	Flare Slope RT (%)	N/A
			N/A	Flare Traversable LT?	N/A	N/A	Flare Traversable RT?	N/A
			N/A	Landing Length (in)	N/A	N/A	DWS Provided?	N/A
			N/A	Landing Width (in)	N/A	N/A	DWS Contrast?	N/A
			N/A	Landing Slope (%)	N/A	N/A	DWS Length (in)	N/A
			N/A	Landing X Slope (%)	N/A	N/A	DWS Full Width?	N/A
Surveyor Notes:		N/A	N/A	Landing Curb? (Y/N)	N/A	N/A	DWS Offset (in)	N/A
PROW/ADA:		Not Found, R304.2.2, R304.5.3	N/A	Shared Landing?	N/A			
			N/A	Gutter Ponding?	N/A	N/A	Gutter Slope (%)	N/A
			N/A	Gutter Lip Ht (in)	N/A	N/A	Gutter X Slope (%)	N/A
