Access Compliance Report

Public Rights-of-Way

(Curb Ramps)

Intersection ID: 3053	Main Street: WHITE_STAG_DR	Cross Street: WHITETAIL_CT	Location: NE
ADA ID: E8774FFB85BA	Ramp Type: Perp	Initial Pass/Fail: Fail	Overall Compliance: No
Severity Score: 10			
Codes/Mitigation Info/Possible Solution		Field Measurements/Component Compliance

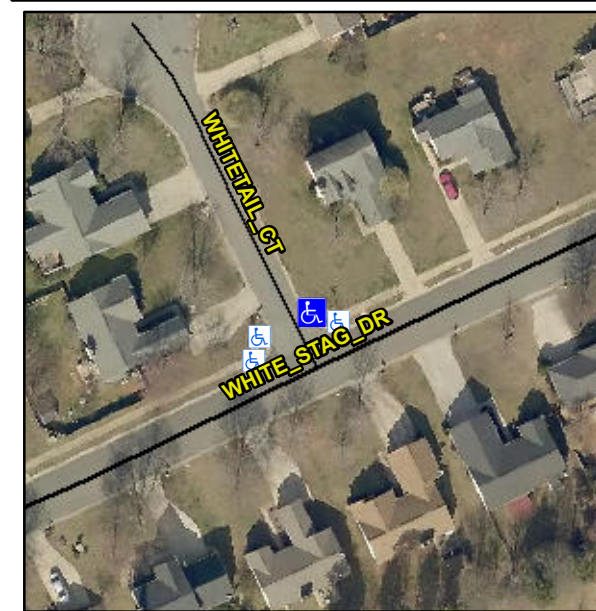
Not Found, R304.5.1, R304.5.3

Compliance	Description	Data	Compliance	Description	Data
N/A	Ramp Length (in)	46.0	Yes	Ramp Slope (%)	8.2
No	Ramp Width (in)	41.0	No	Ramp XSlope (%)	3.0
N/A	Flare Type LT	N/A	N/A	Flare Type RT	N/A
N/A	Flare Slope LT (%)	N/A	N/A	Flare Slope RT (%)	N/A
N/A	Flare Traversable LT?	N/A	N/A	Flare Traversable RT?	N/A
N/A	Landing Length (in)	N/A	N/A	DWS Provided?	N/A
N/A	Landing Width (in)	N/A	N/A	DWS Contrast?	N/A
N/A	Landing Slope (%)	N/A	N/A	DWS Length (in)	N/A
N/A	Landing X Slope (%)	N/A	N/A	DWS Full Width?	N/A
N/A	Landing Curb? (Y/N)	N/A	N/A	DWS Offset (in)	N/A
N/A	Shared Landing?	N/A			
N/A	Gutter Ponding?	N/A	N/A	Gutter Slope (%)	N/A
N/A	Gutter Lip Ht (in)	N/A	N/A	Gutter X Slope (%)	N/A
N/A	Painted X Walk1?	No	N/A	Painted X Walk2?	N/A
	X Walk 1 Direction	To W		X Walk 2 Direction	N/A
N/A	X Walk 1 Width (in)	N/A	N/A	X Walk 2 Width (in)	N/A
	X Walk 1 Slope (%)	1.6		X Walk 2 Slope (%)	N/A
	X Walk 1 X Slope (%)	0.6		X Walk 2 X Slope (%)	N/A

N/A	Ramp inside XWalk1?	N/A	N/A	Ramp inside XWalk2?	N/A
	Road Slope (%)	N/A	N/A	Clear Space?	N/A
	Road X Slope (%)	N/A	N/A	Clear Space to XWalk (in)	N/A
N/A	Any Obstructions?	N/A	N/A	Storm Grate/Utility Hazard?	N/A
	Obstruction Type			Storm Grate/Utility Type	
		N/A			N/A
		Yes		Surface Condition? (G/P)	Good

Remove & Replace Entire Ramp.
