# Access Compliance Report

## Public Rights-of-Way

### (Curb Ramps)

| Intersection ID: 49254 | Main Street: OAKBURN_DR | Cross Street: LEGATO_LN | Location: NW |

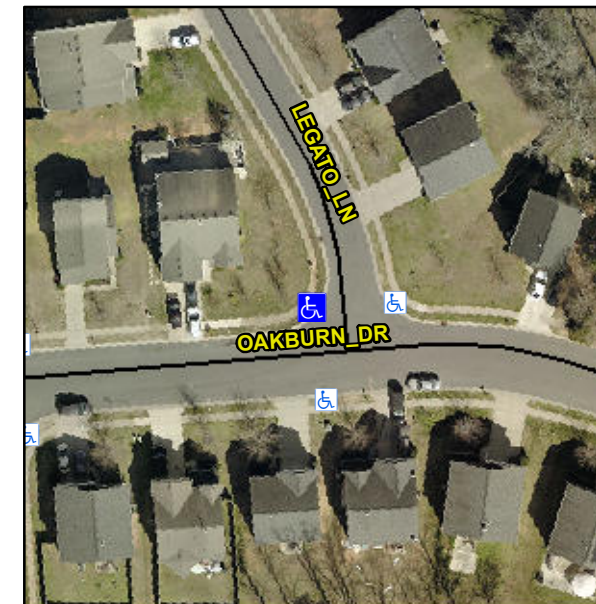
| ADA ID: E8791A97E6BF | Ramp Type: PerpDiag | Initial Pass/Fail: Fail | Overall Compliance: No |
| Severity Score: 10 | | | |

**Not Found, R304.5.1, R304.5.3**

| Compliance | Description | Data | Compliance | Description | Data |
|---|---|---|---|---|---|
| No | Ramp Width (in) | 47.0 | No | Ramp XSlope (%) | 3.2 |

**Remove & Replace Curb Ramp With Two New Directional Ramps or Equivalent.**
