# Access Compliance Report

## Public Rights-of-Way (Curb Ramps)

Intersection ID: 24503	Main Street: BRUFF_CT	Cross Street: SAINTFIELD_PL	Location: NW
ADA ID: E882DE2E665E	Ramp Type: Perp	Initial Pass/Fail: Fail	Overall Compliance: No
		Severity Score: 8.75

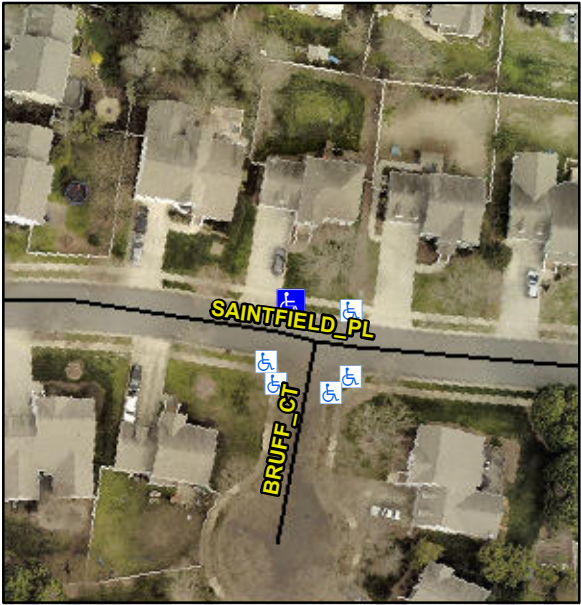
Possible Solutions:		<b>Compliance</b>	<b>Description</b>	<b>Data</b>
	<b>Remove &amp; Replace Entire Ramp.</b>		<b>Yes</b>	Ramp Length (in)	48.0
			<b>No</b>	Ramp Width (in)	47.5
			<b>N/A</b>	Flare Type LT	N/A
			<b>N/A</b>	Flare Slope LT (%)	N/A
			<b>N/A</b>	Flare Traversable LT?	N/A
			<b>N/A</b>	Landing Length (in)	N/A
			<b>N/A</b>	Landing Width (in)	N/A
			<b>N/A</b>	Landing Slope (%)	N/A
			<b>N/A</b>	Landing X Slope (%)	N/A
<p>Surveyor Notes:</p> <p><b>N/A</b></p>			<b>N/A</b>	Landing Curb? (Y/N)	N/A
			<b>N/A</b>	Shared Landing?	N/A
			<b>N/A</b>	Gutter Ponding?	N/A
			<b>N/A</b>	Gutter Lip Ht (in)	N/A
			<b>N/A</b>	Painted X Walk1?	No
			<b>N/A</b>	X Walk 1 Direction	To S
			<b>N/A</b>	X Walk 1 Width (in)	N/A
			<b>N/A</b>	X Walk 1 Slope (%)	2.3
			<b>N/A</b>	X Walk 1 X Slope (%)	0.3
			<b>N/A</b>	Ramp inside XWalk1?	N/A

<p>PROW/ADA:</p> <p><b>Not Found, R304.5.1</b></p>			<b>N/A</b>	Road Slope (%)	N/A
			<b>N/A</b>	Road X Slope (%)	N/A
			<b>N/A</b>	Any Obstructions?	N/A
			<b>N/A</b>	Obstruction Type	
			<b>N/A</b>		
			<b>N/A</b>		
			<b>N/A</b>		
			<b>N/A</b>		
			<b>N/A</b>		
			<b>N/A</b>		
<p>Total Cost:</p> <p><b>\$ 1850.00</b></p>			<b>N/A</b>	Clear Space?	N/A
			<b>N/A</b>	Clear Space to XWalk (in)	N/A
			<b>N/A</b>	Storm Grate/Utility Hazard?	N/A
			<b>N/A</b>	Storm Grate/Utility Type	
			<b>N/A</b>		
			<b>N/A</b>		
			<b>N/A</b>		
			<b>N/A</b>		
			<b>N/A</b>		
			<b>N/A</b>		
<p>Street 1 Name</p> <p><b>SAINTFIELD PL</b></p> <p>Stop Condition-Street 2</p> <p><b>None</b></p> <p>Street 2 Name</p> <p><b>N/A</b></p> <p>Stop Condition-Street 1</p> <p><b>N/A</b></p>			<b>Yes</b>	Surface Condition? (G/P)	<b>Good</b>
