Access Compliance Report

Public Rights-of-Way

(Curb Ramps)

Intersection ID: 27468	Main Street: BALLANTYNE COMMONS PY	Cross Street: JOHN J DELANEY DR	Location: SW
ADA ID: E88EE73B9372	Ramp Type: Perp	Initial Pass/Fail: Fail	Overall Compliance: No
Severity Score: 30			
Codes/Mitigation Info/Possible Solution		Field Measurements/Component Compliance

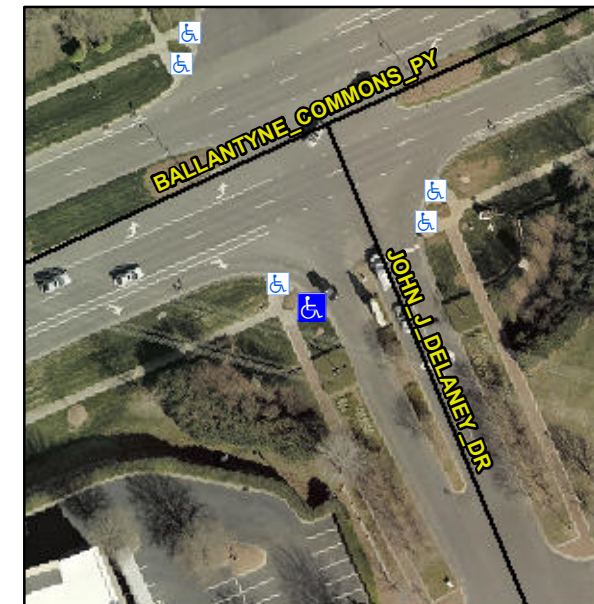
Compliance	Description	Data	Compliance	Description	Data
N/A	Ramp Length (in)	129.0	No	Ramp Slope (%)	10.3
No	Ramp Width (in)	32.0	Yes	Ramp XSlope (%)	0.7
N/A	Flare Type LT	N/A	N/A	Flare Type RT	N/A
N/A	Flare Slope LT (%)	N/A	N/A	Flare Slope RT (%)	N/A
N/A	Flare Traversable LT?	N/A	N/A	Flare Traversable RT?	N/A
N/A	Landing Length (in)	N/A	N/A	DWS Provided?	N/A
N/A	Landing Width (in)	N/A	N/A	DWS Contrast?	N/A
N/A	Landing Slope (%)	N/A	N/A	DWS Length (in)	N/A
N/A	Landing X Slope (%)	N/A	N/A	DWS Full Width?	N/A
N/A	Landing Curb? (Y/N)	N/A	N/A	DWS Offset (in)	N/A
N/A	Shared Landing?	N/A			
N/A	Gutter Ponding?	N/A	N/A	Gutter Slope (%)	N/A
N/A	Gutter Lip Ht (in)	N/A	N/A	Gutter X Slope (%)	N/A
N/A	Painted X Walk1?	No	N/A	Painted X Walk2?	N/A
	X Walk 1 Direction	To E		X Walk 2 Direction	N/A
N/A	X Walk 1 Width (in)	N/A	N/A	X Walk 2 Width (in)	N/A
	X Walk 1 Slope (%)	2.2		X Walk 2 Slope (%)	N/A
	X Walk 1 X Slope (%)	0.1		X Walk 2 X Slope (%)	N/A

N/A	Ramp inside XWalk1?	N/A	N/A	Ramp inside XWalk2?	N/A
	Road Slope (%)	N/A	N/A	Clear Space?	N/A
	Road X Slope (%)	N/A	N/A	Clear Space to XWalk (in)	N/A
N/A	Any Obstructions?	N/A	N/A	Storm Grate/Utility Hazard?	N/A
	Obstruction Type			Storm Grate/Utility Type	
		N/A			N/A
		Yes		Surface Condition? (G/P)	Good

Possible Solutions:

Remove & Replace Entire Ramp.
