Access Compliance Report Public Rights-of-Way (Curb Ramps)

Intersection ID: N/A	Main Street: SANDY PORTER RD	Cross Street: SHUTTERFLY RD	Location: NE
ADA ID: E89DF4B47459	Ramp Type: Directional2	Initial Pass/Fail: Fail	Overall Compliance: No Severity Score: 1.25

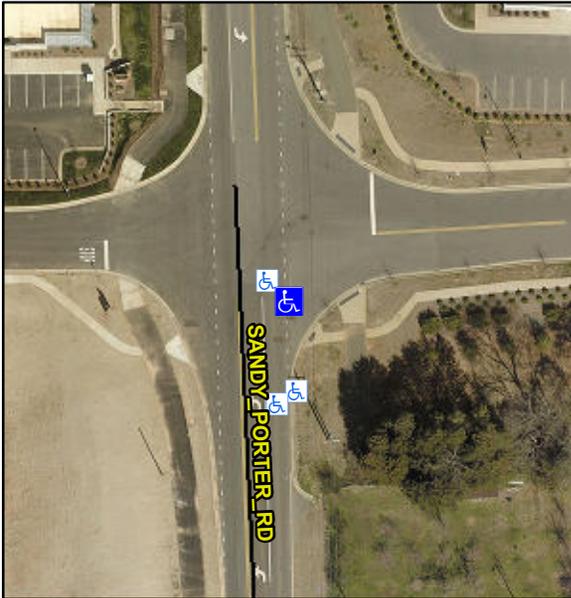
Compliance	Description	Data	Compliance	Description	Data
N/A	Ramp Length (in)	142.0	N/A	Grade Break?	N/A
Yes	Ramp Width (in)	144.0	N/A	Grade Break Slope (%)	0.0
Yes	Ramp Slope (%)	5.7	N/A	Grade Break XSlope (%)	0.0
No	Ramp XSlope (%)	2.7			
N/A	Flare Type LT	N/A	N/A	Flare Type RT	N/A
N/A	Flare Slope LT (%)	N/A	N/A	Flare Slope RT (%)	0.0
N/A	Flare Traversable LT?	N/A	N/A	Flare Traversable RT?	N/A
N/A	Landing Length (in)	0.0	N/A	DWS Provided?	N/A
N/A	Landing Width (in)	0.0	N/A	DWS Contrast?	N/A
N/A	Landing Slope (%)	0.0	N/A	DWS Length (in)	N/A
N/A	Landing X Slope (%)	0.0	N/A	DWS Full Width?	N/A
N/A	Landing Curb? (Y/N)	N/A	N/A	DWS Offset LT (in)	N/A
N/A	Shared Landing?	N/A	N/A	DWS Offset RT (in)	N/A
N/A	Gutter Ponding?	0.0	N/A	Gutter Slope (%)	N/A
N/A	Gutter Lip Ht (in)	0.0	N/A	Gutter X Slope (%)	N/A
N/A	Painted X Walk1?	No		Road Slope (%)	0.7
	X Walk 1 Direction	To SE		Road X Slope (%)	4.2
	X Walk 1 Width (in)	N/A		Clear Space?	N/A

X Walk 1 Slope (%)	0.7	N/A	Clear Space to XWalk (in)	N/A
	X Walk 1 X Slope (%)	4.2	N/A	Storm Grate/Utility Hazard?	N/A
N/A	Ramp inside XWalk1?	N/A		Storm Grate/Utility Type	
N/A	Any Obstructions?	N/A			N/A
	Obstruction Type		Yes	Surface Condition? (G/P)	Good
			N/A	Curb Slope (%)	6.1

Possible Solutions:

Remove & Replace Entire Ramp.
