Intersection ID: 4819	Main Street: CLIFF_CAMERON_DR	Cross Street: WILLIAM_FICKLEN_DR	Location:	SE
ADA ID: E8A5957D9EFA	Ramp Type: PerpDiag	Initial Pass/Fail: Fail	Overall Compliance: No	Severity Score: 33.75

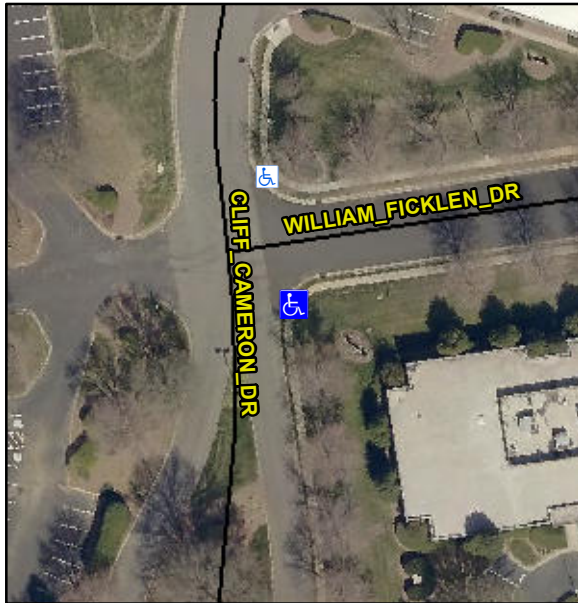
**Not Found, R304.5.1, R304.2.2,
R304.5.3**

Compliance	Description	Data	Compliance	Description	Data
N/A	Ramp Length (in)	72.0	No	Ramp Slope (%)	8.4
No	Ramp Width (in)	46.0	No	Ramp XSlope (%)	5.5
N/A	Flare Type LT	N/A	N/A	Flare Type RT	N/A
N/A	Flare Slope LT (%)	N/A	N/A	Flare Slope RT (%)	N/A
N/A	Flare Traversable LT?	N/A	N/A	Flare Traversable RT?	N/A
N/A	Landing Length (in)	N/A	N/A	DWS Provided?	N/A
N/A	Landing Width (in)	N/A	N/A	DWS Contrast?	N/A
N/A	Landing Slope (%)	N/A	N/A	DWS Length (in)	N/A
N/A	Landing X Slope (%)	N/A	N/A	DWS Full Width?	N/A
N/A	Landing Curb? (Y/N)	N/A	N/A	DWS Offset (in)	N/A
N/A	Shared Landing?	N/A			
N/A	Gutter Ponding?	N/A	N/A	Gutter Slope (%)	N/A
N/A	Gutter Lip Ht (in)	N/A	N/A	Gutter X Slope (%)	N/A
N/A	Painted X Walk1?	No	N/A	Painted X Walk2?	No
	X Walk 1 Direction	To N		X Walk 2 Direction	To W
N/A	X Walk 1 Width (in)	N/A	N/A	X Walk 2 Width (in)	N/A
	X Walk 1 Slope (%)	0.1		X Walk 2 Slope (%)	1.6
	X Walk 1 X Slope (%)	4.7		X Walk 2 X Slope (%)	5.6

N/A	Ramp inside XWalk1?	N/A	N/A	Ramp inside XWalk2?	N/A
	Road Slope (%)	5.0	N/A	Clear Space?	N/A
	Road X Slope (%)	3.4	N/A	Clear Space to XWalk (in)	N/A
N/A	Any Obstructions?	N/A	N/A	Storm Grate/Utility Hazard?	N/A
	Obstruction Type			Storm Grate/Utility Type	
		N/A			N/A
			Yes	Surface Condition? (G/P)	Good

Possible Solutions:

Remove & Replace Curb Ramp With Two New Directional Ramps or Equivalent.

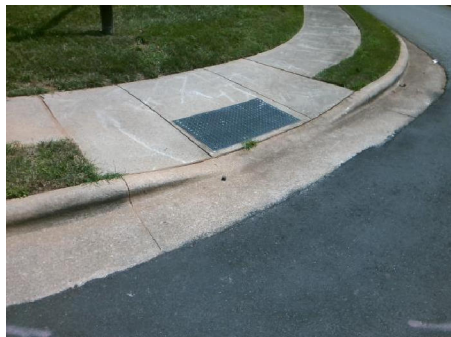
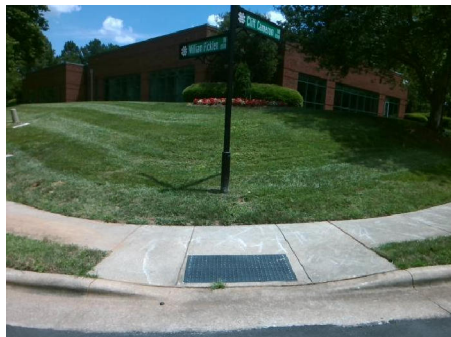
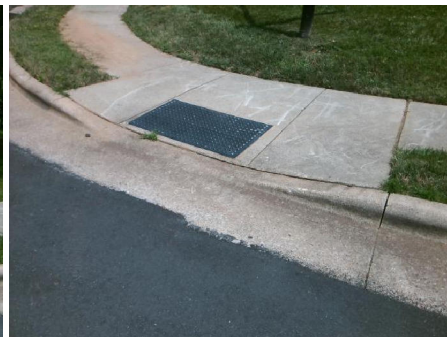
Street 1 Name	WILLIAM FICKLEN DR
Stop Condition-Street 2	StopSign
Street 2 Name	CLIFF CAMERON DR
Stop Condition-Street 1	None
