# Access Compliance Report

## Public Rights-of-Way

Intersection ID: 6739	Main Street: CARRIAGE_OAKS_DR	Cross Street: MINERAL_SPRINGS_RD	Location: S
ADA ID: E8A877469C2E	Ramp Type: Perp	Initial Pass/Fail: Fail	Overall Compliance: No
Severity Score: 12.5			
Codes/Mitigation Info/Possible Solution		Field Measurements/Component Compliance

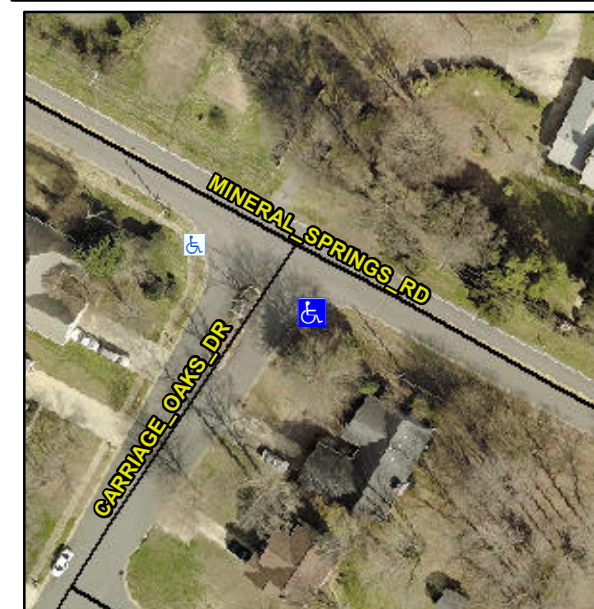
Compliance	Description	Data	Compliance	Description	Data
N/A	Ramp Length (in)	49.0	No	Ramp Slope (%)	8.4
Yes	Ramp Width (in)	48.0	Yes	Ramp XSlope (%)	0.5
N/A	Flare Type LT	N/A	N/A	Flare Type RT	N/A
N/A	Flare Slope LT (%)	N/A	N/A	Flare Slope RT (%)	N/A
N/A	Flare Traversable LT?	N/A	N/A	Flare Traversable RT?	N/A
N/A	Landing Length (in)	N/A	N/A	DWS Provided?	N/A
N/A	Landing Width (in)	N/A	N/A	DWS Contrast?	N/A
N/A	Landing Slope (%)	N/A	N/A	DWS Length (in)	N/A
N/A	Landing X Slope (%)	N/A	N/A	DWS Full Width?	N/A
N/A	Landing Curb? (Y/N)	N/A	N/A	DWS Offset (in)	N/A
N/A	Shared Landing?	N/A			
N/A	Gutter Ponding?	N/A	N/A	Gutter Slope (%)	N/A
N/A	Gutter Lip Ht (in)	N/A	N/A	Gutter X Slope (%)	N/A
N/A	Painted X Walk1?	No	N/A	Painted X Walk2?	N/A
	X Walk 1 Direction	To NW		X Walk 2 Direction	N/A
N/A	X Walk 1 Width (in)	N/A	N/A	X Walk 2 Width (in)	N/A
	X Walk 1 Slope (%)	3.8		X Walk 2 Slope (%)	N/A
	X Walk 1 X Slope (%)	2.1		X Walk 2 X Slope (%)	N/A

N/A	Ramp inside XWalk1?	N/A	N/A	Ramp inside XWalk2?	N/A
	Road Slope (%)	N/A	N/A	Clear Space?	N/A
	Road X Slope (%)	N/A	N/A	Clear Space to XWalk (in)	N/A
N/A	Any Obstructions?	N/A	N/A	Storm Grate/Utility Hazard?	N/A
	Obstruction Type			Storm Grate/Utility Type	
		N/A			N/A
			Yes	Surface Condition? (G/P)	Good

Possible Solutions:

**Remove & Replace Entire Ramp.**
