# Access Compliance Report

## Public Rights-of-Way

### (Curb Ramps)

Intersection ID: 16298	Main Street: YORKMONT_RD	Cross Street: TYVOLA_RD	Location: NE
ADA ID: E8ACBC46C26E	Ramp Type: Perp	Initial Pass/Fail: Fail	Overall Compliance: No
Severity Score: 37.5			
Codes/Mitigation Info/Possible Solution		Field Measurements/Component Compliance

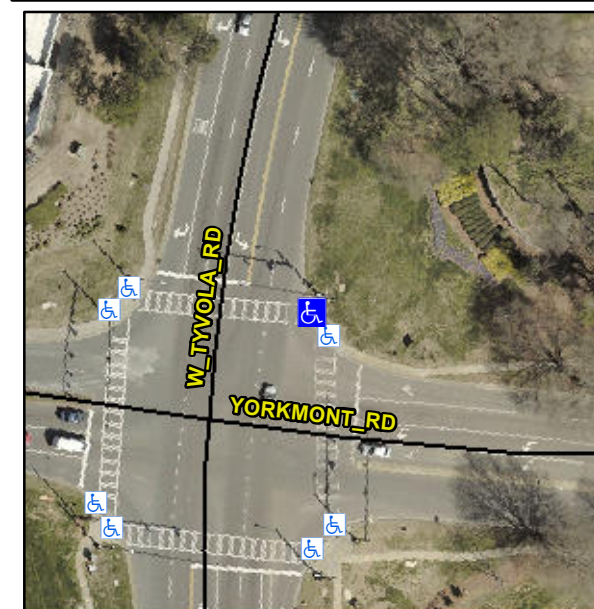
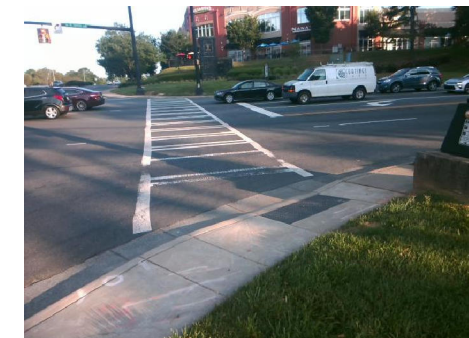
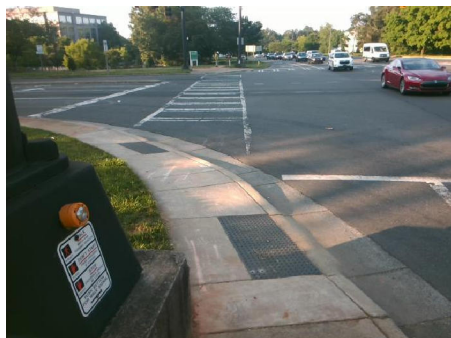
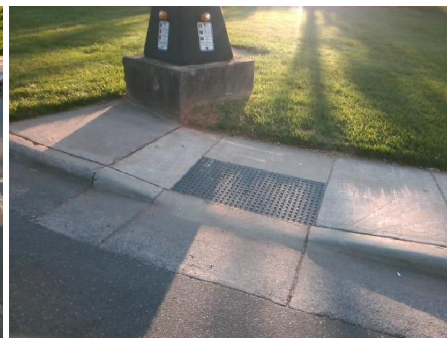
**Not Found, R304.2.2, R304.5.3**

Compliance	Description	Data	Compliance	Description	Data
N/A	Ramp Length (in)	48.0	No	Ramp Slope (%)	8.8
Yes	Ramp Width (in)	48.0	No	Ramp XSlope (%)	8.5
N/A	Flare Type LT	N/A	N/A	Flare Type RT	N/A
N/A	Flare Slope LT (%)	N/A	N/A	Flare Slope RT (%)	N/A
N/A	Flare Traversable LT?	N/A	N/A	Flare Traversable RT?	N/A
N/A	Landing Length (in)	N/A	N/A	DWS Provided?	N/A
N/A	Landing Width (in)	N/A	N/A	DWS Contrast?	N/A
N/A	Landing Slope (%)	N/A	N/A	DWS Length (in)	N/A
N/A	Landing X Slope (%)	N/A	N/A	DWS Full Width?	N/A
N/A	Landing Curb? (Y/N)	N/A	N/A	DWS Offset (in)	N/A
N/A	Shared Landing?	N/A			
N/A	Gutter Ponding?	N/A	N/A	Gutter Slope (%)	N/A
N/A	Gutter Lip Ht (in)	N/A	N/A	Gutter X Slope (%)	N/A
N/A	Painted X Walk1?	Yes	N/A	Painted X Walk2?	N/A
	X Walk 1 Direction	To W		X Walk 2 Direction	N/A
N/A	X Walk 1 Width (in)	110.0	N/A	X Walk 2 Width (in)	N/A
	X Walk 1 Slope (%)	4.2		X Walk 2 Slope (%)	N/A
	X Walk 1 X Slope (%)	1.1		X Walk 2 X Slope (%)	N/A

N/A	Ramp inside XWalk1?	Yes	N/A	Ramp inside XWalk2?	N/A
	Road Slope (%)	N/A	N/A	Clear Space?	N/A
	Road X Slope (%)	N/A	N/A	Clear Space to XWalk (in)	N/A
N/A	Any Obstructions?	N/A	N/A	Storm Grate/Utility Hazard?	N/A
	Obstruction Type			Storm Grate/Utility Type	
		N/A			N/A
		Yes		Surface Condition? (G/P)	Good

**Remove & Replace Entire Ramp.**
