Access Compliance Report

Public Rights-of-Way

(Curb Ramps)

Intersection ID: 10025402	Main Street: E_BLAND_ST	Cross Street: N/A	Location: SE
ADA ID: E8AFA1DCEB6A	Ramp Type: Perp	Initial Pass/Fail: Fail	Overall Compliance: No
Severity Score: 12.5			
Codes/Mitigation Info/Possible Solution		Field Measurements/Component Compliance

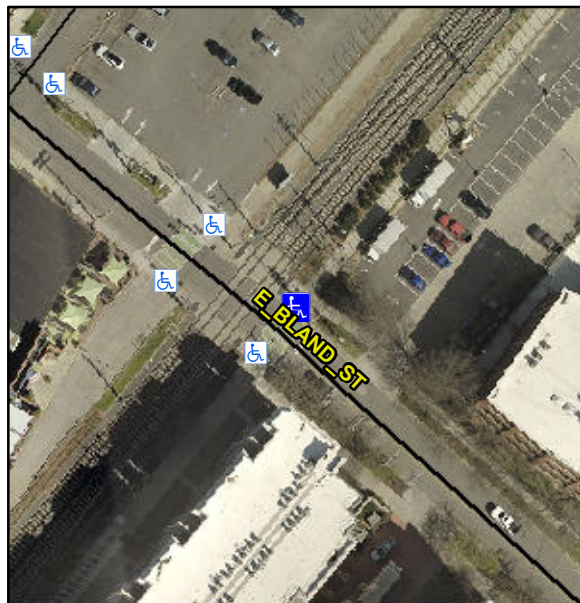
Not Found, R304.2.2

Compliance	Description	Data	Compliance	Description	Data
N/A	Ramp Length (in)	67.0	No	Ramp Slope (%)	9.1
Yes	Ramp Width (in)	91.0	Yes	Ramp XSlope (%)	0.5
N/A	Flare Type LT	N/A	N/A	Flare Type RT	N/A
N/A	Flare Slope LT (%)	N/A	N/A	Flare Slope RT (%)	N/A
N/A	Flare Traversable LT?	N/A	N/A	Flare Traversable RT?	N/A
N/A	Landing Length (in)	N/A	N/A	DWS Provided?	N/A
N/A	Landing Width (in)	N/A	N/A	DWS Contrast?	N/A
N/A	Landing Slope (%)	N/A	N/A	DWS Length (in)	N/A
N/A	Landing X Slope (%)	N/A	N/A	DWS Full Width?	N/A
N/A	Landing Curb? (Y/N)	N/A	N/A	DWS Offset (in)	N/A
N/A	Shared Landing?	N/A			
N/A	Gutter Ponding?	N/A	N/A	Gutter Slope (%)	N/A
N/A	Gutter Lip Ht (in)	N/A	N/A	Gutter X Slope (%)	N/A
N/A	Painted X Walk1?	Yes	N/A	Painted X Walk2?	N/A
	X Walk 1 Direction	To SW		X Walk 2 Direction	N/A
N/A	X Walk 1 Width (in)	171.0	N/A	X Walk 2 Width (in)	N/A
	X Walk 1 Slope (%)	2.8		X Walk 2 Slope (%)	N/A
	X Walk 1 X Slope (%)	0.5		X Walk 2 X Slope (%)	N/A

Possible Solutions:

Remove & Replace Entire Ramp.
