Access Compliance Report

Public Rights-of-Way

(Curb Ramps)

Intersection ID: 5196	Main Street: INTERFACE_LN	Cross Street: KRYSTLE_JUNE_BV	Location: NE
ADA ID: E8B28DBB6437	Ramp Type: Perp	Initial Pass/Fail: Fail	Overall Compliance: No
		Severity Score: 8.75

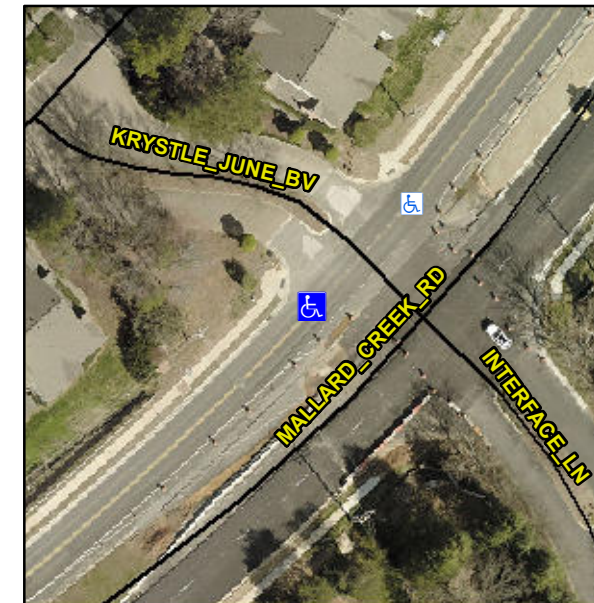
Not Found, R304.5.1

Compliance	Description	Data	Compliance	Description	Data
N/A	Ramp Length (in)	93.0	Yes	Ramp Slope (%)	7.0
No	Ramp Width (in)	41.0	Yes	Ramp XSlope (%)	1.0
N/A	Flare Type LT	N/A	N/A	Flare Type RT	N/A
N/A	Flare Slope LT (%)	N/A	N/A	Flare Slope RT (%)	N/A
N/A	Flare Traversable LT?	N/A	N/A	Flare Traversable RT?	N/A
N/A	Landing Length (in)	N/A	N/A	DWS Provided?	N/A
N/A	Landing Width (in)	N/A	N/A	DWS Contrast?	N/A
N/A	Landing Slope (%)	N/A	N/A	DWS Length (in)	N/A
N/A	Landing X Slope (%)	N/A	N/A	DWS Full Width?	N/A
N/A	Landing Curb? (Y/N)	N/A	N/A	DWS Offset (in)	N/A
N/A	Shared Landing?	N/A			
N/A	Gutter Ponding?	N/A	N/A	Gutter Slope (%)	N/A
N/A	Gutter Lip Ht (in)	N/A	N/A	Gutter X Slope (%)	N/A
N/A	Painted X Walk1?	No	N/A	Painted X Walk2?	N/A
	X Walk 1 Direction	To NE		X Walk 2 Direction	N/A
N/A	X Walk 1 Width (in)	N/A	N/A	X Walk 2 Width (in)	N/A
	X Walk 1 Slope (%)	0.2		X Walk 2 Slope (%)	N/A
	X Walk 1 X Slope (%)	1.0		X Walk 2 X Slope (%)	N/A

Remove & Replace Entire Ramp.

Total Cost: \$ 1850.00
