Access Compliance Report Public Rights-of-Way (Curb Ramps)

Intersection ID: 54049 Main Street: DISTRICT_SOUTH_DR Cross Street: DISTRICT_SOUTH_DR Location: NW

ADA ID: E8B37B2F90F0 Ramp Type: Directional1 Initial Pass/Fail: Fail Overall Compliance: No Severity Score: 13.75

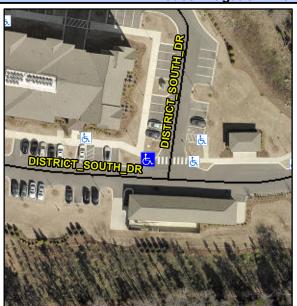
Field Measurements/Component Compliance						
Comp	liance Description	Data	Comp	liance Description	Data	
N/A	Ramp Length (in)	89.0	N/A	Grade Break?	N/A	
Yes	Ramp Width (in)	58.5	N/A	Grade Break Slope (%)	0.0	
No	Ramp Slope (%)	8.9	N/A	Grade Break XSlope (%)	0.0	
No	Ramp XSlope (%)	4.0				
N/A	Flare Type LT	N/A	N/A	Flare Type RT	N/A	
N/A	Flare Slope LT (%)	N/A	N/A	Flare Slope RT (%)	0.0	
N/A	Flare Traversable LT?	N/A	N/A	Flare Traversable RT?	N/A	
N/A	Landing Length (in)	0.0	N/A	DWS Provided?	N/A	
N/A	Landing Width (in)	0.0	N/A	DWS Contrast?	N/A	
N/A	Landing Slope (%)	0.0	N/A	DWS Length (in)	N/A	
N/A	Landing X Slope (%)	0.0	N/A	DWS Full Width?	N/A	
N/A	Landing Curb? (Y/N)	N/A	N/A	DWS Offset LT (in)	N/A	
N/A	Shared Landing?	N/A	N/A	DWS Offset RT (in)	N/A	
N/A	Gutter Ponding?	0.0	N/A	Gutter Slope (%)	N/A	
N/A	Gutter Lip Ht (in)	0.0	N/A	Gutter X Slope (%)	N/A	
N/A	Painted X Walk1?	Yes		Road Slope (%)	0.0	
	X Walk 1 Direction	To E		Road X Slope (%)	1.1

X Walk 1 Width (in)	90.0		Clear Space?	N/A	
	X Walk 1 Slope (%)	0.0	N/A	Clear Space to XWalk (in)	N/A	
	X Walk 1 X Slope (%)	1.1	N/A	Storm Grate/Utility Hazard?	N/A	
N/A	Ramp inside XWalk1?	Yes		Storm Grate/Utility Type		
N/A	Any Obstructions?	N/A			N/A	
	Obstruction Type		Yes	Surface Condition? (G/P)	Good	
		N/A	N/A	Curb Slope (%)	11.1

Possible Solutions:	Com
Remove & Replace Entire Ramp.	N/A
	Yes
	No
	No
	N/A
	N/A
Surveyor Notes:	N/A
N/A	N/A
	N/A
	N/A
	N/A
PROW/ADA:	N/A
R304.2.2, R304.5.3	N/A
·	N/A
	N/A
	N/A
