# Access Compliance Report

## Public Rights-of-Way

### (Curb Ramps)

Intersection ID: 2801	Main Street: BELL'S_MILL_DR	Cross Street: DUNOON_LN	Location: SE
ADA ID: E8BB281B03FD	Ramp Type: PerpDiag	Initial Pass/Fail: Fail	Overall Compliance: No
Severity Score: 33.75			
Codes/Mitigation Info/Possible Solution		Field Measurements/Component Compliance

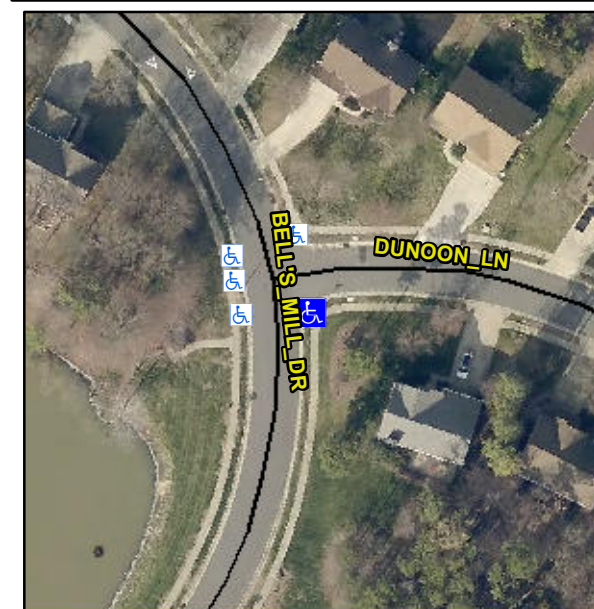
**Not Found, R304.5.1, R304.2.2**

Compliance	Description	Data	Compliance	Description	Data
N/A	Ramp Length (in)	43.0	No	Ramp Slope (%)	15.0
No	Ramp Width (in)	41.0	Yes	Ramp XSlope (%)	1.8
N/A	Flare Type LT	N/A	N/A	Flare Type RT	N/A
N/A	Flare Slope LT (%)	N/A	N/A	Flare Slope RT (%)	N/A
N/A	Flare Traversable LT?	N/A	N/A	Flare Traversable RT?	N/A
N/A	Landing Length (in)	N/A	N/A	DWS Provided?	N/A
N/A	Landing Width (in)	N/A	N/A	DWS Contrast?	N/A
N/A	Landing Slope (%)	N/A	N/A	DWS Length (in)	N/A
N/A	Landing X Slope (%)	N/A	N/A	DWS Full Width?	N/A
N/A	Landing Curb? (Y/N)	N/A	N/A	DWS Offset (in)	N/A
N/A	Shared Landing?	N/A			
N/A	Gutter Ponding?	N/A	N/A	Gutter Slope (%)	N/A
N/A	Gutter Lip Ht (in)	N/A	N/A	Gutter X Slope (%)	N/A
N/A	Painted X Walk1?	No	N/A	Painted X Walk2?	No
	X Walk 1 Direction	To N		X Walk 2 Direction	To W
N/A	X Walk 1 Width (in)	N/A	N/A	X Walk 2 Width (in)	N/A
	X Walk 1 Slope (%)	5.3		X Walk 2 Slope (%)	3.1
	X Walk 1 X Slope (%)	2.2		X Walk 2 X Slope (%)	4.5

N/A	Ramp inside XWalk1?	N/A	N/A	Ramp inside XWalk2?	N/A
	Road Slope (%)	4.8	N/A	Clear Space?	N/A
	Road X Slope (%)	5.0	N/A	Clear Space to XWalk (in)	N/A
N/A	Any Obstructions?	N/A	N/A	Storm Grate/Utility Hazard?	N/A
	Obstruction Type			Storm Grate/Utility Type	
		N/A			N/A
		Yes		Surface Condition? (G/P)	Good

**Remove & Replace Curb Ramp With Two New Directional Ramps or Equivalent.**

Total Cost: \$ 3200.00
