# Access Compliance Report

## Public Rights-of-Way

### (Curb Ramps)

Intersection ID: N/A	Main Street: NORTHLAKE_PLAZA_DR	Cross Street: N/A	Location: NW
ADA ID: E8BD85DE4107	Ramp Type: PerpDiag	Initial Pass/Fail: Fail	Overall Compliance: No
		Severity Score: 25

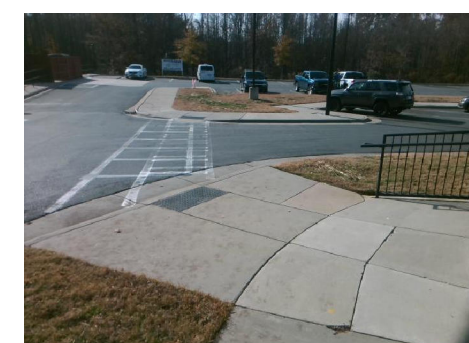
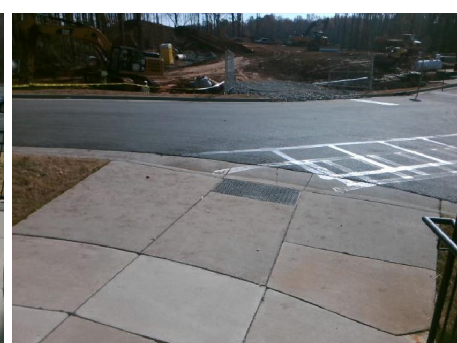
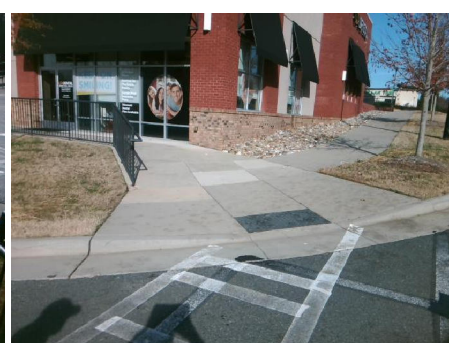
<b>N/A</b>	X Walk 1 Slope (%)	<b>7.8</b>
			<b>N/A</b>	X Walk 1 X Slope (%)	<b>0.6</b>
			<b>N/A</b>	Ramp inside XWalk1?	<b>Yes</b>
<p>Surveyor Notes:</p> <p><b>N/A</b></p> <p>PROW/ADA:</p> <p><b>Not Found, R304.5.3</b></p>			<b>N/A</b>	Flare Type RT	<b>N/A</b>
			<b>N/A</b>	Flare Slope RT (%)	<b>N/A</b>
			<b>N/A</b>	Flare Traversable RT?	<b>No</b>
			<b>N/A</b>	DWS Provided?	<b>N/A</b>
			<b>N/A</b>	DWS Contrast?	<b>N/A</b>
			<b>N/A</b>	DWS Length (in)	<b>N/A</b>
			<b>N/A</b>	DWS Full Width?	<b>N/A</b>
			<b>N/A</b>	DWS Offset (in)	<b>N/A</b>
			<b>N/A</b>	Gutter Slope (%)	<b>N/A</b>
			<b>N/A</b>	Gutter X Slope (%)	<b>N/A</b>
			<b>N/A</b>	Painted X Walk2?	<b>No</b>
			<b>N/A</b>	X Walk 2 Direction	<b>To E</b>
			<b>N/A</b>	X Walk 2 Width (in)	<b>N/A</b>
			<b>N/A</b>	X Walk 2 Slope (%)	<b>0.9</b>
			<b>N/A</b>	X Walk 2 X Slope (%)	<b>7.5</b>
			<b>N/A</b>	Ramp inside XWalk2?	<b>N/A</b>
			<b>N/A</b>	Clear Space?	<b>N/A</b>

Possible Solutions:		<b>Compliance</b>	<b>Description</b>	<b>Data</b>
	<b>Remove &amp; Replace Curb Ramp With Two New Directional Ramps or Equivalent.</b>		<b>Yes</b>	Ramp Length (in)	<b>96.0</b>
			<b>N/A</b>	Ramp Width (in)	<b>48.1</b>
			<b>N/A</b>	Flare Type LT	<b>N/A</b>
			<b>N/A</b>	Flare Slope LT (%)	<b>N/A</b>
			<b>N/A</b>	Flare Traversable LT?	<b>No</b>
			<b>N/A</b>	Landing Length (in)	<b>N/A</b>
			<b>N/A</b>	Landing Width (in)	<b>N/A</b>
			<b>N/A</b>	Landing Slope (%)	<b>N/A</b>
			<b>N/A</b>	Landing X Slope (%)	<b>N/A</b>
			<b>N/A</b>	Landing Curb? (Y/N)	<b>N/A</b>
			<b>N/A</b>	Shared Landing?	<b>N/A</b>
			<b>N/A</b>	Gutter Ponding?	<b>N/A</b>
			<b>N/A</b>	Gutter Lip Ht (in)	<b>N/A</b>
			<b>N/A</b>	Painted X Walk1?	<b>Yes</b>
			<b>N/A</b>	X Walk 1 Direction	<b>To S</b>
			<b>N/A</b>	X Walk 1 Width (in)	<b>57.0</b>
