Access Compliance Report

Public Rights-of-Way

(Curb Ramps)

Intersection ID: 12721	Main Street: S_CHURCH_ST	Cross Street: W_HILL_ST	Location: W
ADA ID: E8C011044CB2	Ramp Type: Perp	Initial Pass/Fail: Fail	Overall Compliance: No
			Severity Score: 50

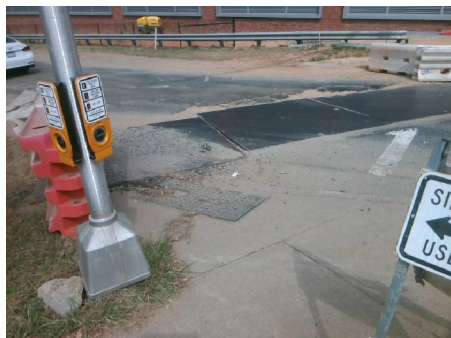
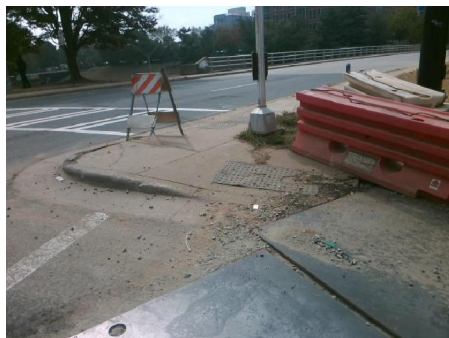
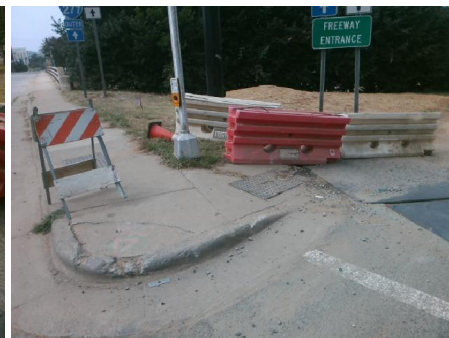
Not Found, R304.2.2, R304.5.3

Compliance	Description	Data	Compliance	Description	Data
N/A	Ramp Length (in)	64.0	No	Ramp Slope (%)	14.2
Yes	Ramp Width (in)	58.0	No	Ramp XSlope (%)	11.2
N/A	Flare Type LT	N/A	N/A	Flare Type RT	N/A
N/A	Flare Slope LT (%)	N/A	N/A	Flare Slope RT (%)	N/A
N/A	Flare Traversable LT?	N/A	N/A	Flare Traversable RT?	N/A
N/A	Landing Length (in)	N/A	N/A	DWS Provided?	N/A
N/A	Landing Width (in)	N/A	N/A	DWS Contrast?	N/A
N/A	Landing Slope (%)	N/A	N/A	DWS Length (in)	N/A
N/A	Landing X Slope (%)	N/A	N/A	DWS Full Width?	N/A
N/A	Landing Curb? (Y/N)	N/A	N/A	DWS Offset (in)	N/A
N/A	Shared Landing?	N/A			
N/A	Gutter Ponding?	N/A	N/A	Gutter Slope (%)	N/A
N/A	Gutter Lip Ht (in)	N/A	N/A	Gutter X Slope (%)	N/A
N/A	Painted X Walk1?	No	N/A	Painted X Walk2?	N/A
	X Walk 1 Direction	To NE		X Walk 2 Direction	N/A
N/A	X Walk 1 Width (in)	N/A	N/A	X Walk 2 Width (in)	N/A
	X Walk 1 Slope (%)	3.4		X Walk 2 Slope (%)	N/A
	X Walk 1 X Slope (%)	7.1		X Walk 2 X Slope (%)	N/A

Remove & Replace Entire Ramp.
