Access Compliance Report

Public Rights-of-Way

(Curb Ramps)

Intersection ID: 3766	Main Street: OLYMPUS_DR	Cross Street: SHIMMERING_LAKE_DR	Location: W
ADA ID: E8C7527405E3	Ramp Type: BlendTrans1	Initial Pass/Fail: Fail	Overall Compliance: No
		Severity Score: 21.25

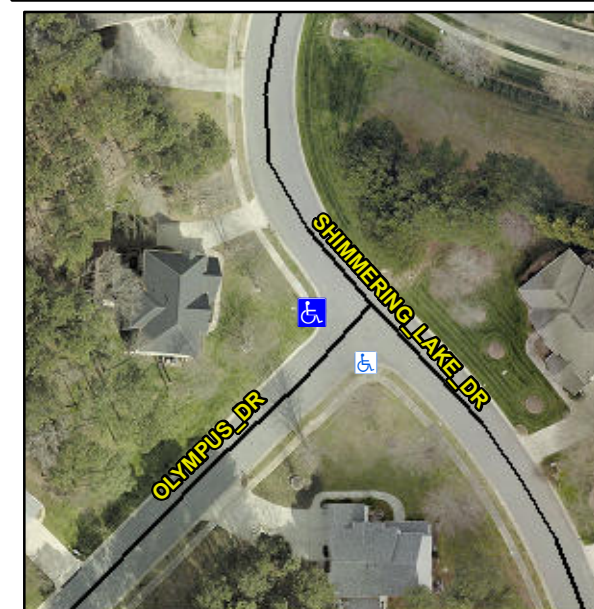
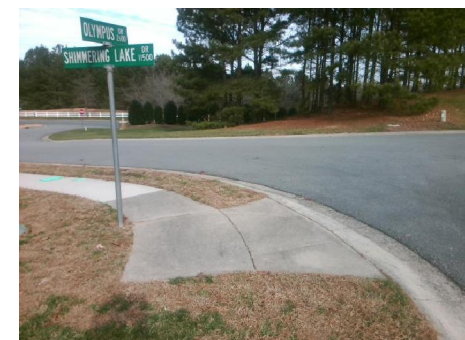
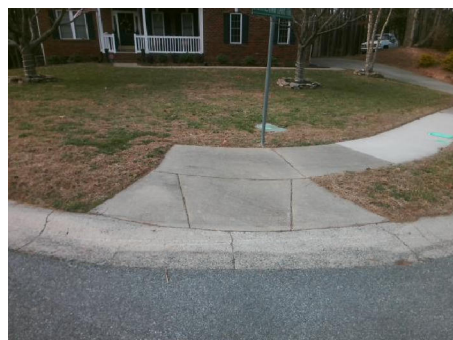
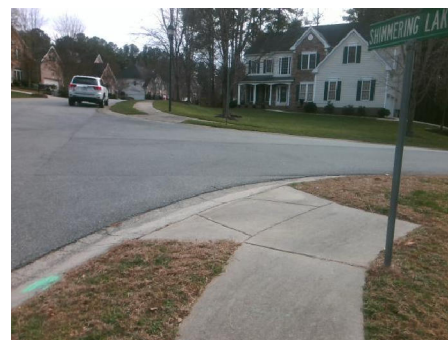
Compliance	Description	Data	Compliance	Description	Data
N/A	Ramp Length (in)	46.0	Yes	BlendTrans Slope (%)	2.6
No	Ramp Width (in)	39.0	No	BlendTrans XSlope (%)	5.6
N/A	Flare Type LT	N/A	N/A	Flare Type RT	N/A
N/A	Flare Slope LT (%)	N/A	N/A	Flare Slope RT (%)	N/A
N/A	Flare Traversable LT?	N/A	N/A	Flare Traversable RT?	N/A
N/A	Landing Length (in)	N/A	N/A	DWS Provided?	N/A
N/A	Landing Width (in)	N/A	N/A	DWS Contrast?	N/A
N/A	Landing Slope (%)	N/A	N/A	DWS Length (in)	N/A
N/A	Landing X Slope (%)	N/A	N/A	DWS Full Width?	N/A
N/A	Landing Curb? (Y/N)	N/A	N/A	DWS Offset (in)	N/A
N/A	Shared Landing?	N/A			
N/A	Gutter Ponding?	N/A	N/A	Gutter Slope (%)	N/A
N/A	Gutter Lip Ht (in)	N/A	N/A	Gutter X Slope (%)	N/A
N/A	Painted X Walk1?	No	N/A	Painted X Walk2?	N/A
	X Walk 1 Direction	To SE		X Walk 2 Direction	N/A
	X Walk 1 Width (in)	N/A		X Walk 2 Width (in)	N/A
	X Walk 1 Slope (%)	10.2		X Walk 2 Slope (%)	N/A
	X Walk 1 X Slope (%)	2.8		X Walk 2 X Slope (%)	N/A

N/A	Ramp inside XWalk1?	N/A	N/A	Ramp inside XWalk2?	N/A
	Road Slope (%)	2.8		Clear Space?	N/A
	Road X Slope (%)	10.2	N/A	Clear Space to XWalk (in)	N/A
N/A	Any Obstructions?	N/A	N/A	Storm Grate/Utility Hazard?	N/A
	Obstruction Type			Storm Grate/Utility Type	
		N/A			N/A
			Yes	Surface Condition? (G/P)	Good
			N/A	Curb Slope (%)	4.8

Remove & Replace Curb Ramp With Two New Directional Ramps or Equivalent.

R304.5.1, R304.5.3
