# Access Compliance Report

## Public Rights-of-Way

| Intersection ID: 15737 | Main Street: HUNTLEY_PL | Cross Street: PROVIDENCE_RD | Location: NE |
| ADA ID: E8C9409D0FBF | Ramp Type: PerpDiag | Initial Pass/Fail: Fail | Overall Compliance: No |

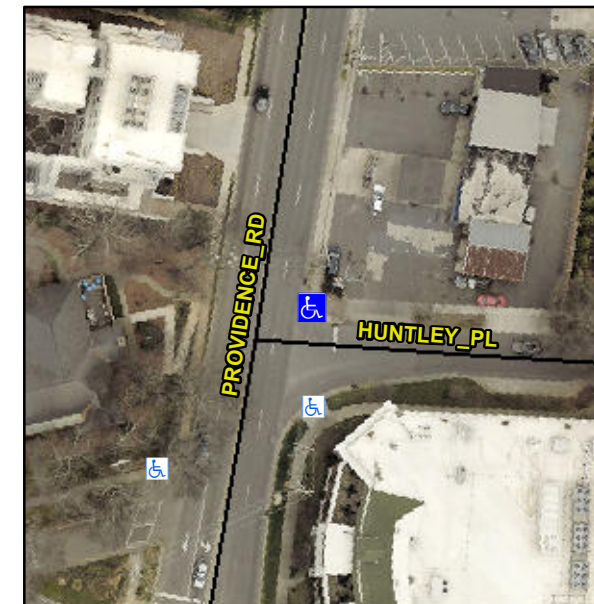
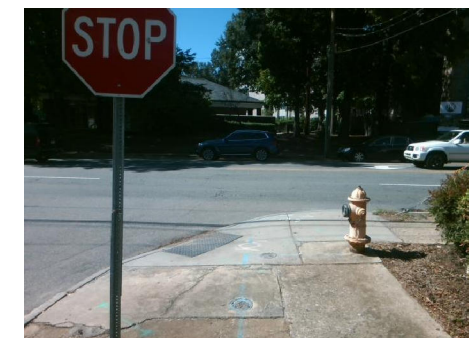
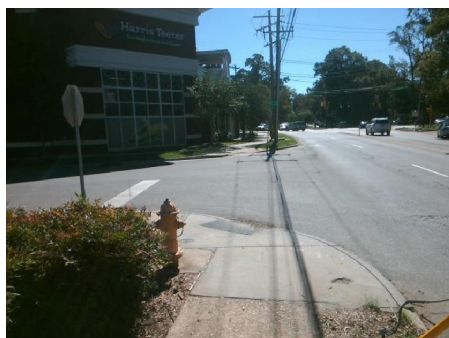
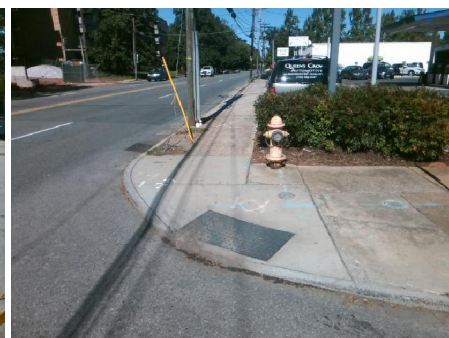
| | | Severity Score: 12.5 | |

**Not Found, R304.2.2**

| Compliance | Description | Data | Compliance | Description | Data |
|---|---|---|---|---|---|
| N/A | Ramp Length (in) | 77.5 | No | Ramp Slope (%) | 9.1 |
| Yes | Ramp Width (in) | 48.0 | Yes | Ramp XSlope (%) | 0.0 |

**Remove & Replace Curb Ramp With Two New Directional Ramps or Equivalent.**

Total Cost: \$ 3200.00
