# Access Compliance Report

## Public Rights-of-Way

### (Curb Ramps)

| Intersection ID: 11698 | Main Street: S CEDAR ST | Cross Street: W 4TH ST | Location: SW |

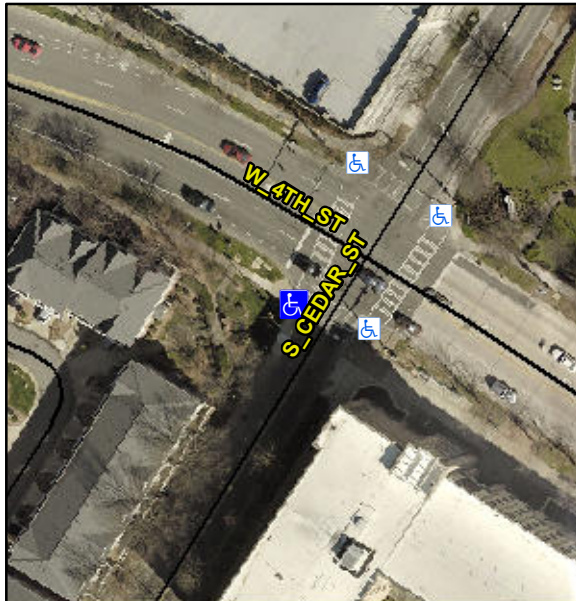
**Not Found, R304.5.3, R304.2.1, R304.2.2-Perp, R304.3.2-Para, R305.1.4, R305.2**

| Compliance | Description | Data | Compliance | Description | Data |
|---|---|---|---|---|---|
| Yes | Ramp Width (in) | 48.0 | No | Ramp XSlope (%) | 2.5 |
| No | Landing Length (in) | N/A | Yes | DWS Provided? | Yes |
| No | Landing X Slope (%) | N/A | No | DWS Full Width? | No |
| N/A | Landing Curb? (Y/N) | No | No | DWS Offset (in) | 7.5 |

**Remove & Replace Curb Ramp With Two New Directional Ramps or Equivalent.**
