Access Compliance Report

Public Rights-of-Way

(Curb Ramps)

Intersection ID: 10012572	Main Street: TYNER_ST	Cross Street: N/A	Location: SE
ADA ID: E8CD6A21FA8F	Ramp Type: PerpDiag	Initial Pass/Fail: Pass	Overall Compliance: No
Severity Score: 5.25			
Codes/Mitigation Info/Possible Solution		Field Measurements/Component Compliance

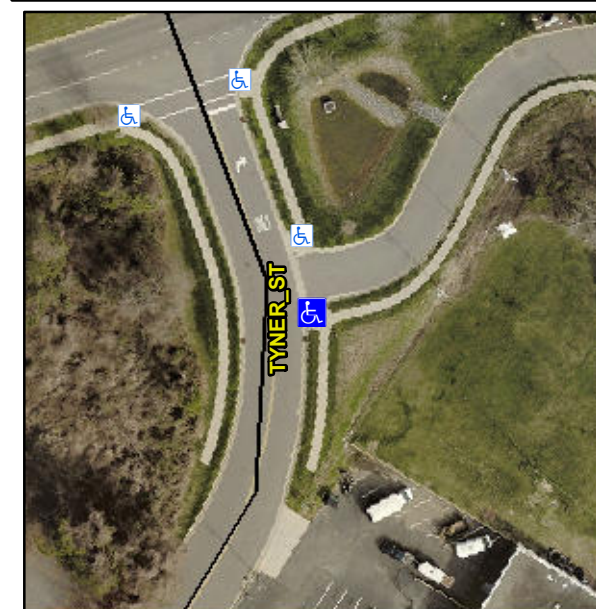
Not Found, R304.5.3, R304.2.2-Perp, R304.3.2-Para, R305.2, R304.5.4

Compliance	Description	Data	Compliance	Description	Data
N/A	Ramp Length (in)	69.0	Yes	Ramp Slope (%)	5.8
Yes	Ramp Width (in)	48.0	No	Ramp XSlope (%)	2.3
N/A	Flare Type LT	Sloped	N/A	Flare Type RT	N/A
N/A	Flare Slope LT (%)	6.9	N/A	Flare Slope RT (%)	3.7
N/A	Flare Traversable LT?	No	N/A	Flare Traversable RT?	No
Yes	Landing Length (in)	61.0	Yes	DWS Provided?	Yes
Yes	Landing Width (in)	60.0	Yes	DWS Contrast?	Yes
No	Landing Slope (%)	2.2	Yes	DWS Length (in)	24.0
No	Landing X Slope (%)	5.4	Yes	DWS Full Width?	Yes
N/A	Landing Curb? (Y/N)	No	No	DWS Offset (in)	2.5
N/A	Shared Landing?	No			
Yes	Gutter Ponding?	No	No	Gutter Slope (%)	5.5
Yes	Gutter Lip Ht (in)	0.0	No	Gutter X Slope (%)	3.1
N/A	Painted X Walk1?	No	N/A	Painted X Walk2?	No
	X Walk 1 Direction	To N		X Walk 2 Direction	To W
N/A	X Walk 1 Width (in)	N/A	N/A	X Walk 2 Width (in)	N/A
	X Walk 1 Slope (%)	1.2		X Walk 2 Slope (%)	3.9
	X Walk 1 X Slope (%)	6.0		X Walk 2 X Slope (%)	0.7

N/A	Ramp inside XWalk1?	N/A	N/A	Ramp inside XWalk2?	N/A
	Road Slope (%)	4.6	N/A	Clear Space?	Yes
	Road X Slope (%)	4.6	N/A	Clear Space to XWalk (in)	N/A
Yes	Any Obstructions?	No	Yes	Storm Grate/Utility Hazard?	No
	Obstruction Type			Storm Grate/Utility Type	
		N/A			N/A
		Yes		Surface Condition? (G/P)	Good

Remove & Replace Curb Ramp With Two New Directional Ramps or Equivalent. Remove & Replace Gutter.
