Access Compliance Report

Public Rights-of-Way

(Curb Ramps)

Intersection ID: 12110	Main Street: S_MINT_ST	Cross Street: W_4TH_ST	Location: S
ADA ID: E8D52622DBAA	Ramp Type: Perp	Initial Pass/Fail: Fail	Overall Compliance: No
		Severity Score: 12.5

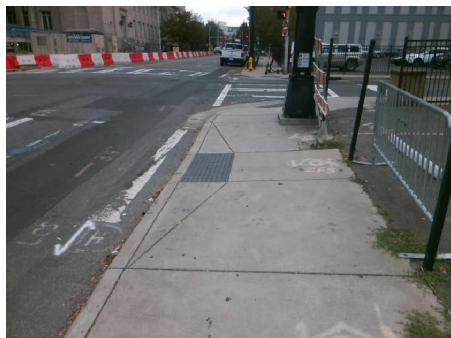
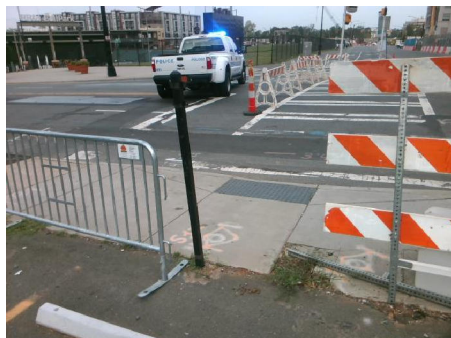
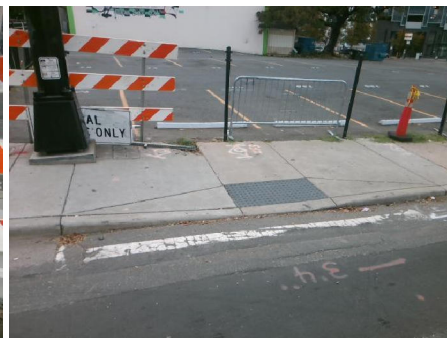
Not Found, R304.5.3

Compliance	Description	Data	Compliance	Description	Data
N/A	Ramp Length (in)	85.0	Yes	Ramp Slope (%)	7.7
Yes	Ramp Width (in)	49.0	No	Ramp XSlope (%)	6.1
N/A	Flare Type LT	N/A	N/A	Flare Type RT	N/A
N/A	Flare Slope LT (%)	N/A	N/A	Flare Slope RT (%)	N/A
N/A	Flare Traversable LT?	N/A	N/A	Flare Traversable RT?	N/A
N/A	Landing Length (in)	N/A	N/A	DWS Provided?	N/A
N/A	Landing Width (in)	N/A	N/A	DWS Contrast?	N/A
N/A	Landing Slope (%)	N/A	N/A	DWS Length (in)	N/A
N/A	Landing X Slope (%)	N/A	N/A	DWS Full Width?	N/A
N/A	Landing Curb? (Y/N)	N/A	N/A	DWS Offset (in)	N/A
N/A	Shared Landing?	N/A			
N/A	Gutter Ponding?	N/A	N/A	Gutter Slope (%)	N/A
N/A	Gutter Lip Ht (in)	N/A	N/A	Gutter X Slope (%)	N/A
N/A	Painted X Walk1?	Yes	N/A	Painted X Walk2?	N/A
	X Walk 1 Direction	To NW		X Walk 2 Direction	N/A
N/A	X Walk 1 Width (in)	136.0	N/A	X Walk 2 Width (in)	N/A
	X Walk 1 Slope (%)	7.2		X Walk 2 Slope (%)	N/A
	X Walk 1 X Slope (%)	4.8		X Walk 2 X Slope (%)	N/A

N/A	Ramp inside XWalk1?	Yes	N/A	Ramp inside XWalk2?	N/A
	Road Slope (%)	N/A	N/A	Clear Space?	N/A
	Road X Slope (%)	N/A	N/A	Clear Space to XWalk (in)	N/A
N/A	Any Obstructions?	N/A	N/A	Storm Grate/Utility Hazard?	N/A
	Obstruction Type			Storm Grate/Utility Type	
		N/A			N/A
			Yes	Surface Condition? (G/P)	Good

Possible Solutions:

Remove & Replace Entire Ramp.
