# Access Compliance Report

## Public Rights-of-Way

### (Curb Ramps)

| Intersection ID: 10038358 | Main Street: SOUTH_BV | Cross Street: N/A | Location: SE |

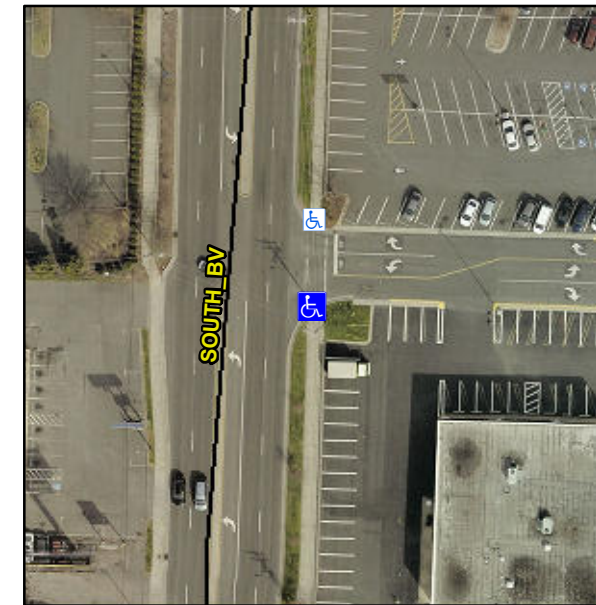
| ADA ID: E8D925560B66 | Ramp Type: Directional1 | Initial Pass/Fail: Pass | Overall Compliance: No |
| | | Severity Score: 2.5 | |

| Compliance | Description | Data | Compliance | Description | Data |
|---|---|---|---|---|---|
| No | Landing Slope (%) | 2.3 | Yes | DWS Length (in) | 24.0 |
| No | Landing X Slope (%) | 2.2 | No | DWS Full Width? | No |

**Remove & Replace Entire Ramp.**
