# Access Compliance Report

## Public Rights-of-Way

### (Curb Ramps)

| Intersection ID: N/A | Main Street: PAISLEY_ABBEY_LN | Cross Street: KELBURN_LN | Location: SE |

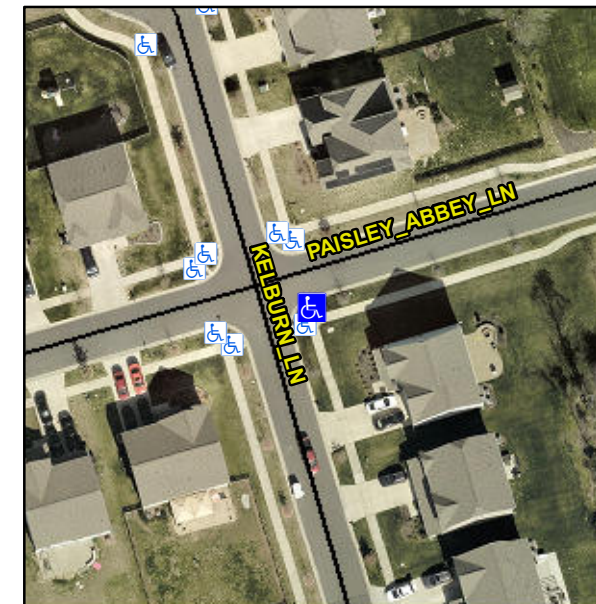
| ADA ID: E8E4999F7ECE | Ramp Type: BlendTrans1 | Initial Pass/Fail: Fail | Overall Compliance: No |
| Severity Score: 8.75 | | | |

**Not Found, R304.5.1**

| Compliance | Description | Data | Compliance | Description | Data |
|---|---|---|---|---|---|
| No | Ramp Width (in) | 46.0 | Yes | BlendTrans XSlope (%) | 1.0 |

**Remove & Replace Curb Ramp With Two New Directional Ramps or Equivalent.**

Total Cost: \$ 3200.00

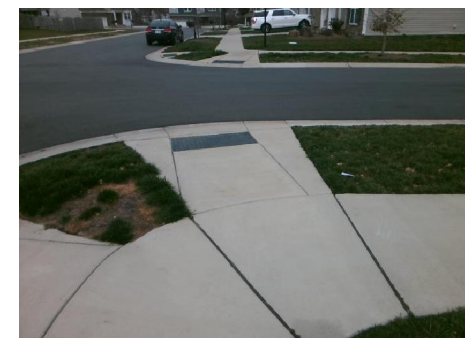
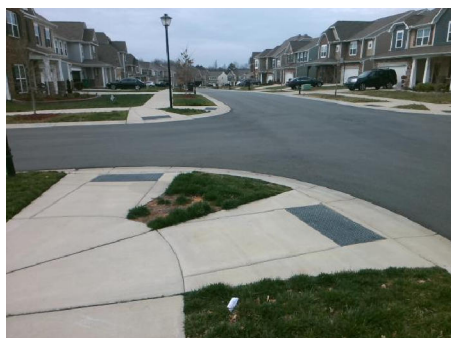
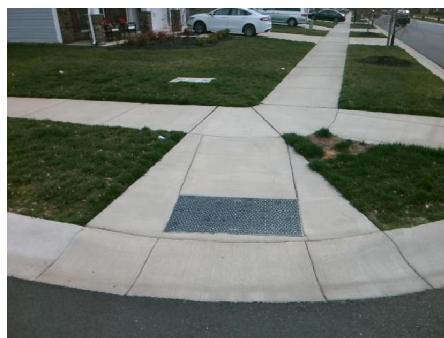
| Compliance | Description | Data | Compliance | Description | Data |
|---|---|---|---|---|---|
| | | | No | Curb Slope (%) | 8.4 |
