Access Compliance Report

Public Rights-of-Way

(Curb Ramps)

Intersection ID: 23475	Main Street: QUAIL_HOLLOW_RD	Cross Street: WOODGLEN_LN	Location: SE
ADA ID: E8E66FC1DBF3	Ramp Type: PerpDiag	Initial Pass/Fail: Fail	Overall Compliance: No
Severity Score: 35			
Codes/Mitigation Info/Possible Solution		Field Measurements/Component Compliance

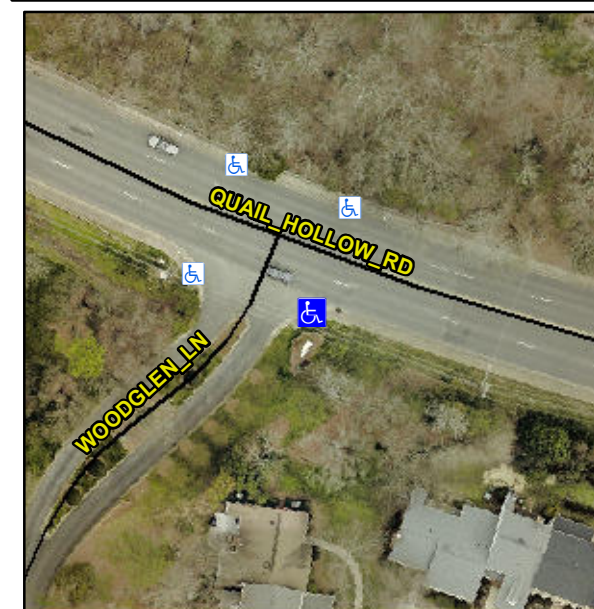
Not Found, R304.5.1, R304.2.2, R304.5.3

Compliance	Description	Data	Compliance	Description	Data
N/A	Ramp Length (in)	59.0	No	Ramp Slope (%)	12.8
No	Ramp Width (in)	36.0	No	Ramp XSlope (%)	2.2
N/A	Flare Type LT	N/A	N/A	Flare Type RT	N/A
N/A	Flare Slope LT (%)	N/A	N/A	Flare Slope RT (%)	N/A
N/A	Flare Traversable LT?	N/A	N/A	Flare Traversable RT?	N/A
N/A	Landing Length (in)	N/A	N/A	DWS Provided?	N/A
N/A	Landing Width (in)	N/A	N/A	DWS Contrast?	N/A
N/A	Landing Slope (%)	N/A	N/A	DWS Length (in)	N/A
N/A	Landing X Slope (%)	N/A	N/A	DWS Full Width?	N/A
N/A	Landing Curb? (Y/N)	N/A	N/A	DWS Offset (in)	N/A
N/A	Shared Landing?	N/A			
N/A	Gutter Ponding?	N/A	N/A	Gutter Slope (%)	N/A
N/A	Gutter Lip Ht (in)	N/A	N/A	Gutter X Slope (%)	N/A
N/A	Painted X Walk1?	No	N/A	Painted X Walk2?	No
	X Walk 1 Direction	To NE		X Walk 2 Direction	To NW
N/A	X Walk 1 Width (in)	N/A	N/A	X Walk 2 Width (in)	N/A
	X Walk 1 Slope (%)	1.3		X Walk 2 Slope (%)	0.5
	X Walk 1 X Slope (%)	2.7		X Walk 2 X Slope (%)	0.4

N/A	Ramp inside XWalk1?	N/A	N/A	Ramp inside XWalk2?	N/A
	Road Slope (%)	1.1	N/A	Clear Space?	N/A
	Road X Slope (%)	0.7	N/A	Clear Space to XWalk (in)	N/A
N/A	Any Obstructions?	N/A	N/A	Storm Grate/Utility Hazard?	N/A
	Obstruction Type			Storm Grate/Utility Type	
		N/A			N/A
			Yes	Surface Condition? (G/P)	Good

Remove & Replace Curb Ramp With Two New Directional Ramps or Equivalent.
