Access Compliance Report

Public Rights-of-Way

(Curb Ramps)

Intersection ID: N/A	Main Street: MONROE_RD	Cross Street: PUHLMAN_ST	Location: SW
ADA ID: E8F5E78E2EBF	Ramp Type: PerpDiag	Initial Pass/Fail: Fail	Overall Compliance: No
		Severity Score: 35

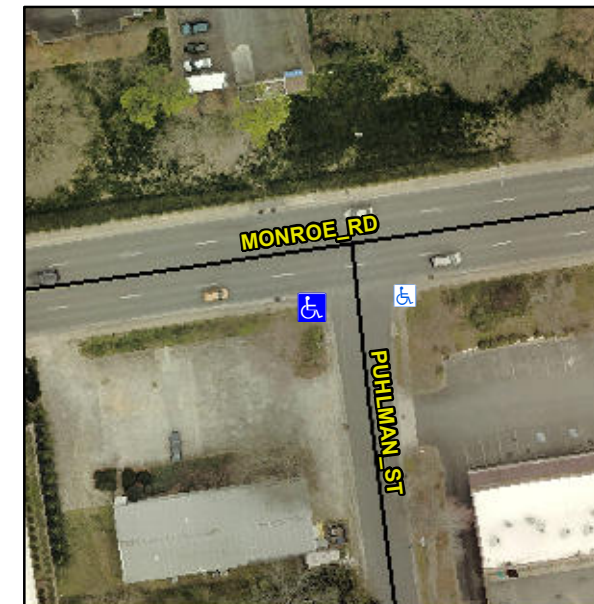
Not Found, R304.5.1, R304.2.2, R304.5.3

Compliance	Description	Data	Compliance	Description	Data
N/A	Ramp Length (in)	58.0	No	Ramp Slope (%)	13.2
No	Ramp Width (in)	40.0	No	Ramp XSlope (%)	4.0
N/A	Flare Type LT	N/A	N/A	Flare Type RT	N/A
N/A	Flare Slope LT (%)	N/A	N/A	Flare Slope RT (%)	N/A
N/A	Flare Traversable LT?	N/A	N/A	Flare Traversable RT?	N/A
N/A	Landing Length (in)	N/A	N/A	DWS Provided?	N/A
N/A	Landing Width (in)	N/A	N/A	DWS Contrast?	N/A
N/A	Landing Slope (%)	N/A	N/A	DWS Length (in)	N/A
N/A	Landing X Slope (%)	N/A	N/A	DWS Full Width?	N/A
N/A	Landing Curb? (Y/N)	N/A	N/A	DWS Offset (in)	N/A
N/A	Shared Landing?	N/A			
N/A	Gutter Ponding?	N/A	N/A	Gutter Slope (%)	N/A
N/A	Gutter Lip Ht (in)	N/A	N/A	Gutter X Slope (%)	N/A
N/A	Painted X Walk1?	No	N/A	Painted X Walk2?	No
	X Walk 1 Direction	To E		X Walk 2 Direction	To N
N/A	X Walk 1 Width (in)	N/A	N/A	X Walk 2 Width (in)	N/A
	X Walk 1 Slope (%)	1.9		X Walk 2 Slope (%)	2.3
	X Walk 1 X Slope (%)	4.1		X Walk 2 X Slope (%)	3.2

N/A	Ramp inside XWalk1?	N/A	N/A	Ramp inside XWalk2?	N/A
	Road Slope (%)	3.3	N/A	Clear Space?	N/A
	Road X Slope (%)	0.6	N/A	Clear Space to XWalk (in)	N/A
N/A	Any Obstructions?	N/A	N/A	Storm Grate/Utility Hazard?	N/A
	Obstruction Type			Storm Grate/Utility Type	
		N/A			N/A
			Yes	Surface Condition? (G/P)	Good

Remove & Replace Curb Ramp With Two New Directional Ramps or Equivalent.
