# Access Compliance Report

## Public Rights-of-Way

### (Curb Ramps)

| Intersection ID: 10025885 | Main Street: ELIZABETH_AV | Cross Street: N/A | Location: | N |

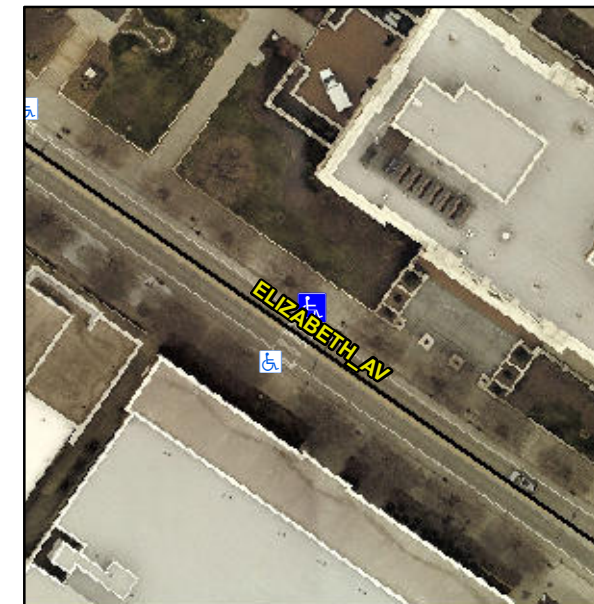
**Not Found, R304.2.3, R304.5.3**

| Compliance | Description | Data | Compliance | Description | Data |
|---|---|---|---|---|---|
| N/A | Flare Slope LT (%) | 1.1 | No | Flare Slope RT (%) | 11.8 |
| Yes | Gutter Lip Ht (in) | 0.0 | No | Gutter X Slope (%) | 6.7 |

Possible Solutions:

**Remove & Replace Entire Ramp.  
Remove & Replace Gutter.**
