Access Compliance Report

Public Rights-of-Way

(Curb Ramps)

Intersection ID: 49705	Main Street: LOUGHLIN_LN	Cross Street: VAUGHAN_DR	Location: NE
ADA ID: E8FC7FA7393C	Ramp Type: PerpDiag	Initial Pass/Fail: Fail	Overall Compliance: No
Severity Score: 22.5			
Codes/Mitigation Info/Possible Solution		Field Measurements/Component Compliance

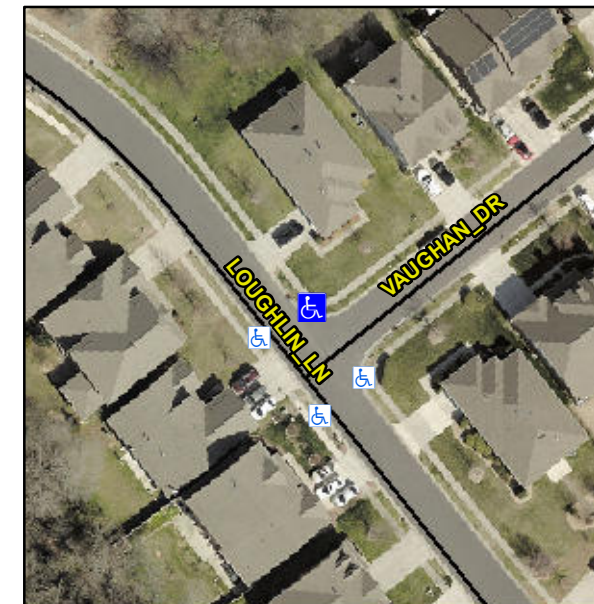
Not Found, R304.5.1, R304.2.2, R304.5.3

Compliance	Description	Data	Compliance	Description	Data
N/A	Ramp Length (in)	47.0	No	Ramp Slope (%)	10.2
No	Ramp Width (in)	47.5	No	Ramp XSlope (%)	4.4
N/A	Flare Type LT	N/A	N/A	Flare Type RT	N/A
N/A	Flare Slope LT (%)	N/A	N/A	Flare Slope RT (%)	N/A
N/A	Flare Traversable LT?	N/A	N/A	Flare Traversable RT?	N/A
N/A	Landing Length (in)	N/A	N/A	DWS Provided?	N/A
N/A	Landing Width (in)	N/A	N/A	DWS Contrast?	N/A
N/A	Landing Slope (%)	N/A	N/A	DWS Length (in)	N/A
N/A	Landing X Slope (%)	N/A	N/A	DWS Full Width?	N/A
N/A	Landing Curb? (Y/N)	N/A	N/A	DWS Offset (in)	N/A
N/A	Shared Landing?	N/A			
N/A	Gutter Ponding?	N/A	N/A	Gutter Slope (%)	N/A
N/A	Gutter Lip Ht (in)	N/A	N/A	Gutter X Slope (%)	N/A
N/A	Painted X Walk1?	No	N/A	Painted X Walk2?	No
	X Walk 1 Direction	To SW		X Walk 2 Direction	To SE
N/A	X Walk 1 Width (in)	N/A	N/A	X Walk 2 Width (in)	N/A
	X Walk 1 Slope (%)	2.3		X Walk 2 Slope (%)	2.6
	X Walk 1 X Slope (%)	4.1		X Walk 2 X Slope (%)	0.5

N/A	Ramp inside XWalk1?	N/A	N/A	Ramp inside XWalk2?	N/A
	Road Slope (%)	5.2	N/A	Clear Space?	N/A
	Road X Slope (%)	3.1	N/A	Clear Space to XWalk (in)	N/A
N/A	Any Obstructions?	N/A	N/A	Storm Grate/Utility Hazard?	N/A
	Obstruction Type			Storm Grate/Utility Type	
		N/A			N/A
			Yes	Surface Condition? (G/P)	Good

Remove & Replace Curb Ramp With Two New Directional Ramps or Equivalent.
