Access Compliance Report

Public Rights-of-Way

(Curb Ramps)

Intersection ID: 30613	Main Street: GOLF_LINKS_DR	Cross Street: PROVIDENCE_RD	Location: SE
ADA ID: E9177FD9BCC6	Ramp Type: Perp	Initial Pass/Fail: Fail	Overall Compliance: No
Severity Score: 8.75			
Codes/Mitigation Info/Possible Solution		Field Measurements/Component Compliance

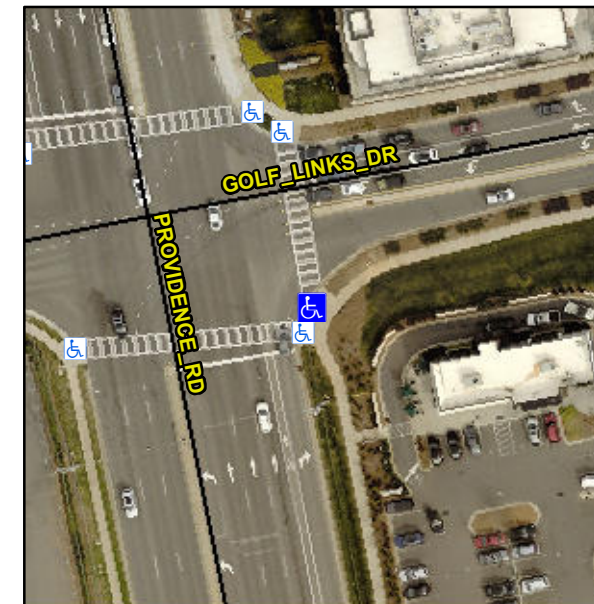
Not Found, R304.5.1

Compliance	Description	Data	Compliance	Description	Data
N/A	Ramp Length (in)	96.0	Yes	Ramp Slope (%)	7.5
No	Ramp Width (in)	46.5	Yes	Ramp XSlope (%)	0.3
N/A	Flare Type LT	N/A	N/A	Flare Type RT	N/A
N/A	Flare Slope LT (%)	N/A	N/A	Flare Slope RT (%)	N/A
N/A	Flare Traversable LT?	N/A	N/A	Flare Traversable RT?	N/A
N/A	Landing Length (in)	N/A	N/A	DWS Provided?	N/A
N/A	Landing Width (in)	N/A	N/A	DWS Contrast?	N/A
N/A	Landing Slope (%)	N/A	N/A	DWS Length (in)	N/A
N/A	Landing X Slope (%)	N/A	N/A	DWS Full Width?	N/A
N/A	Landing Curb? (Y/N)	N/A	N/A	DWS Offset (in)	N/A
N/A	Shared Landing?	N/A			
N/A	Gutter Ponding?	N/A	N/A	Gutter Slope (%)	N/A
N/A	Gutter Lip Ht (in)	N/A	N/A	Gutter X Slope (%)	N/A
N/A	Painted X Walk1?	No	N/A	Painted X Walk2?	N/A
	X Walk 1 Direction	To N		X Walk 2 Direction	N/A
N/A	X Walk 1 Width (in)	N/A	N/A	X Walk 2 Width (in)	N/A
	X Walk 1 Slope (%)	5.3		X Walk 2 Slope (%)	N/A
	X Walk 1 X Slope (%)	2.4		X Walk 2 X Slope (%)	N/A

N/A	Ramp inside XWalk1?	N/A	N/A	Ramp inside XWalk2?	N/A
	Road Slope (%)	N/A	N/A	Clear Space?	N/A
	Road X Slope (%)	N/A	N/A	Clear Space to XWalk (in)	N/A
N/A	Any Obstructions?	N/A	N/A	Storm Grate/Utility Hazard?	N/A
	Obstruction Type			Storm Grate/Utility Type	
		N/A			N/A
			Yes	Surface Condition? (G/P)	Good

Possible Solutions:

Remove & Replace Entire Ramp.
