Access Compliance Report

Public Rights-of-Way

(Curb Ramps)

Intersection ID: 10032680	Main Street: N_LAUREL_AV	Cross Street: N/A	Location: SE
ADA ID: E91B8A7DFE68	Ramp Type: Directional1	Initial Pass/Fail: Fail	Overall Compliance: No
Codes/Mitigation Info/Possible Solution		Field Measurements/Component Compliance

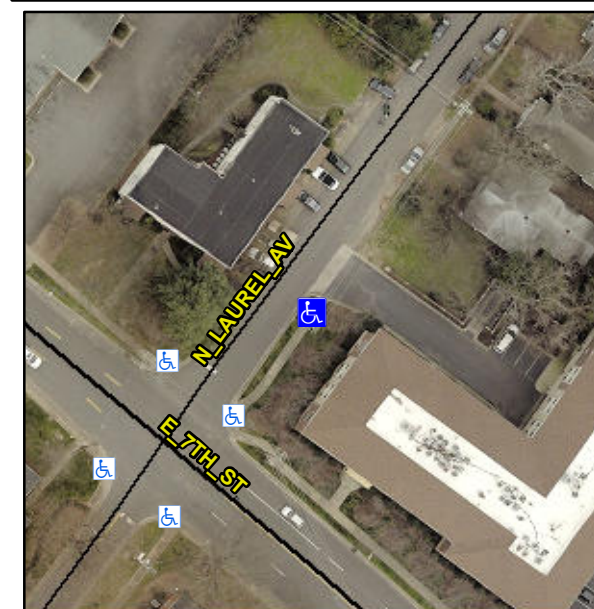
Compliance	Description	Data	Compliance	Description	Data
N/A	Ramp Length (in)	184.0	N/A	Grade Break?	N/A
Yes	Ramp Width (in)	59.5	N/A	Grade Break Slope (%)	0.0
Yes	Ramp Slope (%)	12.7	N/A	Grade Break XSlope (%)	0.0
Yes	Ramp XSlope (%)	2.8			
N/A	Flare Type LT	N/A	N/A	Flare Type RT	N/A
N/A	Flare Slope LT (%)	N/A	N/A	Flare Slope RT (%)	0.0
N/A	Flare Traversable LT?	N/A	N/A	Flare Traversable RT?	N/A
N/A	Landing Length (in)	0.0	N/A	DWS Provided?	N/A
N/A	Landing Width (in)	0.0	N/A	DWS Contrast?	N/A
N/A	Landing Slope (%)	0.0	N/A	DWS Length (in)	N/A
N/A	Landing X Slope (%)	0.0	N/A	DWS Full Width?	N/A
N/A	Landing Curb? (Y/N)	N/A	N/A	DWS Offset LT (in)	N/A
N/A	Shared Landing?	N/A	N/A	DWS Offset RT (in)	N/A
N/A	Gutter Ponding?	0.0	N/A	Gutter Slope (%)	N/A
N/A	Gutter Lip Ht (in)	0.0	N/A	Gutter X Slope (%)	N/A
N/A	Painted X Walk1?	No		Road Slope (%)	1.3
	X Walk 1 Direction	To N		Road X Slope (%)	4.7
	X Walk 1 Width (in)	N/A		Clear Space?	N/A

X Walk 1 Slope (%)	1.3	N/A	Clear Space to XWalk (in)	N/A
	X Walk 1 X Slope (%)	4.7	N/A	Storm Grate/Utility Hazard?	N/A
N/A	Ramp inside XWalk1?	N/A		Storm Grate/Utility Type	
N/A	Any Obstructions?	N/A			N/A
	Obstruction Type		Yes	Surface Condition? (G/P)	Good
			N/A	Curb Slope (%)	11.0

Possible Solutions:

Remove & Replace Entire Ramp.
