Access Compliance Report Public Rights-of-Way (Curb Ramps)

Intersection ID: 2509	Main Street: LYNNEWOOD_GLEN_DR	Cross Street: WHITEGATE_LN	Location: SE
ADA ID: E91C087E2EC9	Ramp Type: PerpDiag	Initial Pass/Fail: Fail	Overall Compliance: No Severity Score: 22.5

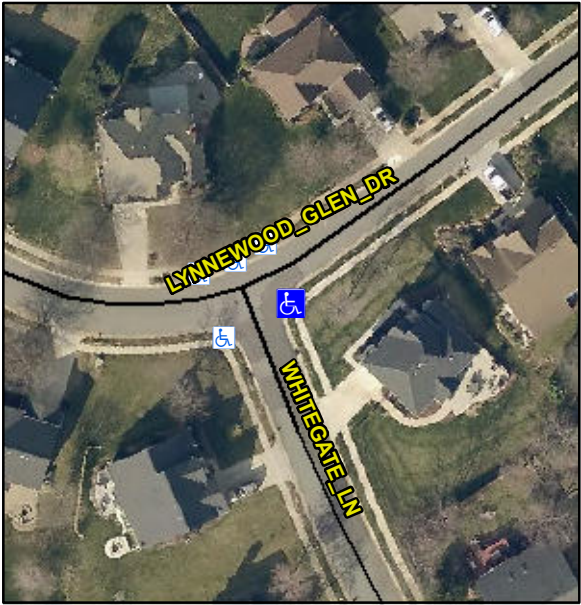
Compliance	Description	Data	Compliance	Description	Data
N/A	Ramp Length (in)	46.0	No	Ramp Slope (%)	9.2
No	Ramp Width (in)	45.0	No	Ramp XSlope (%)	2.9
N/A	Flare Type LT	N/A	N/A	Flare Type RT	N/A
N/A	Flare Slope LT (%)	N/A	N/A	Flare Slope RT (%)	N/A
N/A	Flare Traversable LT?	N/A	N/A	Flare Traversable RT?	N/A
N/A	Landing Length (in)	N/A	N/A	DWS Provided?	N/A
N/A	Landing Width (in)	N/A	N/A	DWS Contrast?	N/A
N/A	Landing Slope (%)	N/A	N/A	DWS Length (in)	N/A
N/A	Landing X Slope (%)	N/A	N/A	DWS Full Width?	N/A
N/A	Landing Curb? (Y/N)	N/A	N/A	DWS Offset (in)	N/A
N/A	Shared Landing?	N/A			
N/A	Gutter Ponding?	N/A	N/A	Gutter Slope (%)	N/A
N/A	Gutter Lip Ht (in)	N/A	N/A	Gutter X Slope (%)	N/A
N/A	Painted X Walk1?	No	N/A	Painted X Walk2?	No
	X Walk 1 Direction	To N		X Walk 2 Direction	To W
N/A	X Walk 1 Width (in)	N/A	N/A	X Walk 2 Width (in)	N/A
	X Walk 1 Slope (%)	1.5		X Walk 2 Slope (%)	2.3
	X Walk 1 X Slope (%)	1.8		X Walk 2 X Slope (%)	1.3

N/A	Ramp inside XWalk1?	N/A	N/A	Ramp inside XWalk2?	N/A
	Road Slope (%)	2.4	N/A	Clear Space?	N/A
	Road X Slope (%)	1.0	N/A	Clear Space to XWalk (in)	N/A
N/A	Any Obstructions?	N/A	N/A	Storm Grate/Utility Hazard?	N/A
	Obstruction Type			Storm Grate/Utility Type	
		N/A			N/A
			Yes	Surface Condition? (G/P)	Good

Possible Solutions:
Remove & Replace Curb Ramp With Two New Directional Ramps or Equivalent.

PROW/ADA:
R304.5.1, R304.2.2, R304.5.3
