Access Compliance Report

Public Rights-of-Way

(Curb Ramps)

Intersection ID: 10020687	Main Street: BEAM_RD	Cross Street: N/A	Location: E
ADA ID: E91CBB888CC9	Ramp Type: Perp	Initial Pass/Fail: Fail	Overall Compliance: No
Severity Score: 13.75			
Codes/Mitigation Info/Possible Solution		Field Measurements/Component Compliance

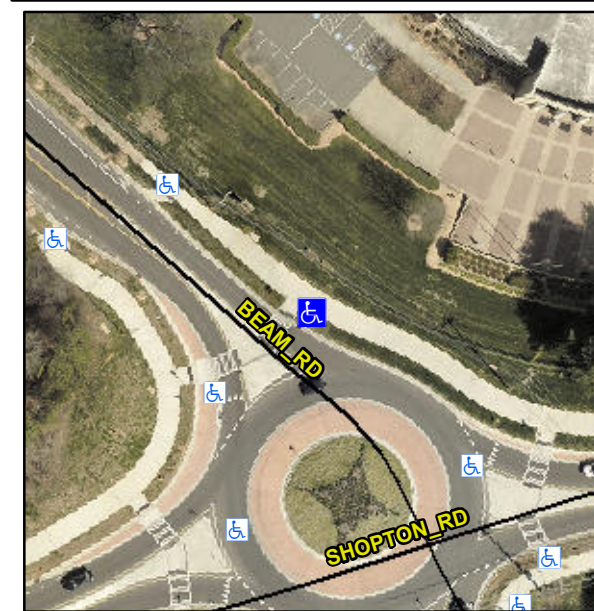
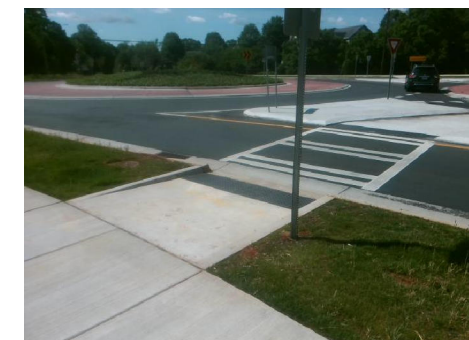
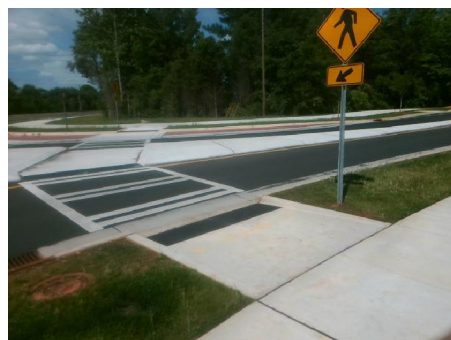
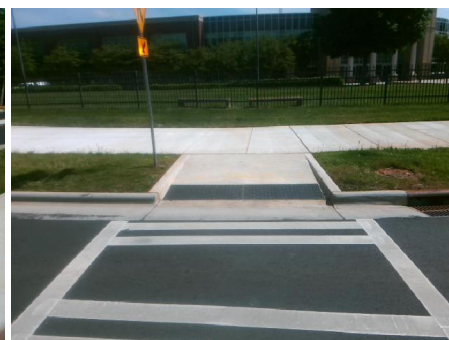
Not Found, R304.2.2, R304.5.3

Compliance	Description	Data	Compliance	Description	Data
N/A	Ramp Length (in)	96.0	No	Ramp Slope (%)	8.8
Yes	Ramp Width (in)	97.0	No	Ramp XSlope (%)	3.5
N/A	Flare Type LT	N/A	N/A	Flare Type RT	N/A
N/A	Flare Slope LT (%)	N/A	N/A	Flare Slope RT (%)	N/A
N/A	Flare Traversable LT?	N/A	N/A	Flare Traversable RT?	N/A
N/A	Landing Length (in)	N/A	N/A	DWS Provided?	N/A
N/A	Landing Width (in)	N/A	N/A	DWS Contrast?	N/A
N/A	Landing Slope (%)	N/A	N/A	DWS Length (in)	N/A
N/A	Landing X Slope (%)	N/A	N/A	DWS Full Width?	N/A
N/A	Landing Curb? (Y/N)	N/A	N/A	DWS Offset (in)	N/A
N/A	Shared Landing?	N/A			
N/A	Gutter Ponding?	N/A	N/A	Gutter Slope (%)	N/A
N/A	Gutter Lip Ht (in)	N/A	N/A	Gutter X Slope (%)	N/A
N/A	Painted X Walk1?	Yes	N/A	Painted X Walk2?	N/A
	X Walk 1 Direction	To W		X Walk 2 Direction	N/A
N/A	X Walk 1 Width (in)	112.0	N/A	X Walk 2 Width (in)	N/A
	X Walk 1 Slope (%)	2.4		X Walk 2 Slope (%)	N/A
	X Walk 1 X Slope (%)	3.4		X Walk 2 X Slope (%)	N/A

N/A	Ramp inside XWalk1?	Yes	N/A	Ramp inside XWalk2?	N/A
	Road Slope (%)	N/A	N/A	Clear Space?	N/A
	Road X Slope (%)	N/A	N/A	Clear Space to XWalk (in)	N/A
N/A	Any Obstructions?	N/A	N/A	Storm Grate/Utility Hazard?	N/A
	Obstruction Type			Storm Grate/Utility Type	
		N/A			N/A
		Yes		Surface Condition? (G/P)	Good

Possible Solutions:

Remove & Replace Entire Ramp.
