## **Access Compliance Report Public Rights-of-Way** (Curb Ramps)

Intersection ID: 22758 Main Street: RIDGE OAK DR **Cross Street: MOSS RD** Location: SW **Overall Compliance: No** ADA ID: E93699D72F66 Ramp Type: BlendTrans2 Initial Pass/Fail: Fail **Severity Score:** 10

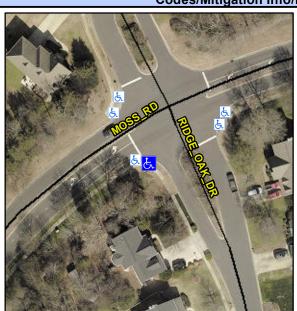
Not Found, R304.5.1, R304.5.3

Compliance Description		Data	Comp	liance Description	Data
N/A	Ramp Length (in)	95.0	Yes	BlendTrans Slope (%)	3.5
No	Ramp Width (in)	43.0	No	BlendTrans XSlope (%)	2.5
N/A	Flare Type LT	N/A	N/A	Flare Type RT	N/A
N/A	Flare Slope LT (%)	N/A	N/A	Flare Slope RT (%)	N/A
N/A	Flare Traversable LT?	N/A	N/A	Flare Traversable RT?	N/A
N/A	Landing Length (in)	N/A	N/A	DWS Provided?	N/A
N/A	Landing Width (in)	N/A	N/A	DWS Contrast?	N/A
N/A	Landing Slope (%)	N/A	N/A	DWS Length (in)	N/A
N/A	Landing X Slope (%)	N/A	N/A	DWS Full Width?	N/A
N/A	Landing Curb? (Y/N)	N/A	N/A	DWS Offset (in)	N/A
N/A	Shared Landing?	N/A			
N/A	Gutter Ponding?	N/A	N/A	Gutter Slope (%)	N/A
N/A	Gutter Lip Ht (in)	N/A	N/A	Gutter X Slope (%)	N/A
N/A	Painted X Walk1?	No	N/A	Painted X Walk2?	N/A
	X Walk 1 Direction	To NE		X Walk 2 Direction	N/A
	X Walk 1 Width (in)	N/A		X Walk 2 Width (in)	N/A
	X Walk 1 Slope (%)	0.6		X Walk 2 Slope (%)	N/A
	X Walk 1 X Slope (%)	1.5		X Walk 2 X Slope (%)	N/A

N/A	Ramp inside XWalk1?	N/A	N/A	Ramp inside XWalk2?	N/A
	Road Slope (%)	1.5		Clear Space?	N/A
	Road X Slope (%)	0.6	N/A	Clear Space to XWalk (in)	N/A
N/A	Any Obstructions?	N/A	N/A	Storm Grate/Utility Hazard?	N/A
	Obstruction Type		l	Storm Grate/Utility Type	
		N/A	l		N/A
			Yes	Surface Condition? (G/P)	Good
			No	Curb Slope (%)	15.2

**RIDGE OAK DR** Street 1 Name Stop Condition-Street 1 StopSign Street 2 Name N/A Stop Condition-Street 2 N/A **Remove & Replace Curb Ramp With Two New Directional Ramps or** Equivalent.

PROW/ADA: Total Cost:

3200.00
