Access Compliance Report

Public Rights-of-Way

(Curb Ramps)

Intersection ID: 45967	Main Street: FOREST_MEADOW_DR	Cross Street: IDLEWILD_RD_NORTH	Location: S
ADA ID: E93E5A8C974C	Ramp Type: BlendTrans1	Initial Pass/Fail: Fail	Overall Compliance: No
Severity Score: 8.75			
Codes/Mitigation Info/Possible Solution		Field Measurements/Component Compliance

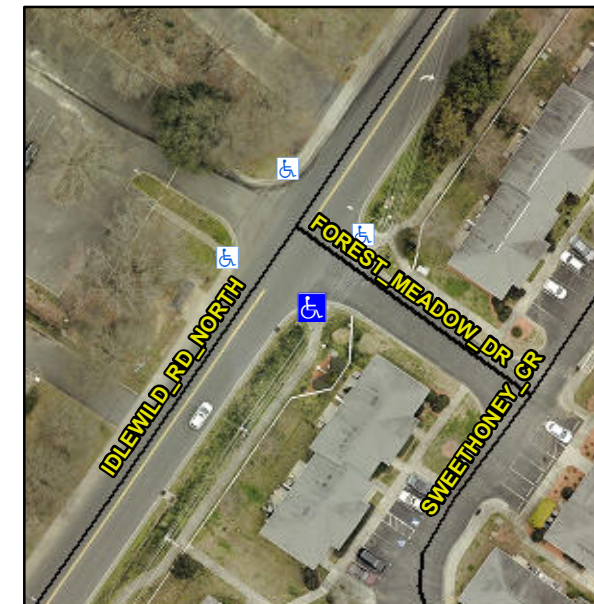
Not Found, R304.5.1

Compliance	Description	Data	Compliance	Description	Data
N/A	Ramp Length (in)	71.0	Yes	BlendTrans Slope (%)	3.5
No	Ramp Width (in)	46.5	Yes	BlendTrans XSlope (%)	1.0
N/A	Flare Type LT	N/A	N/A	Flare Type RT	N/A
N/A	Flare Slope LT (%)	N/A	N/A	Flare Slope RT (%)	N/A
N/A	Flare Traversable LT?	N/A	N/A	Flare Traversable RT?	N/A
N/A	Landing Length (in)	N/A	N/A	DWS Provided?	N/A
N/A	Landing Width (in)	N/A	N/A	DWS Contrast?	N/A
N/A	Landing Slope (%)	N/A	N/A	DWS Length (in)	N/A
N/A	Landing X Slope (%)	N/A	N/A	DWS Full Width?	N/A
N/A	Landing Curb? (Y/N)	N/A	N/A	DWS Offset (in)	N/A
N/A	Shared Landing?	N/A			
N/A	Gutter Ponding?	N/A	N/A	Gutter Slope (%)	N/A
N/A	Gutter Lip Ht (in)	N/A	N/A	Gutter X Slope (%)	N/A
N/A	Painted X Walk1?	No	N/A	Painted X Walk2?	No
	X Walk 1 Direction	To NE		X Walk 2 Direction	To NW
	X Walk 1 Width (in)	N/A		X Walk 2 Width (in)	N/A
	X Walk 1 Slope (%)	5.2		X Walk 2 Slope (%)	7.7
	X Walk 1 X Slope (%)	5.8		X Walk 2 X Slope (%)	4.0

N/A	Ramp inside XWalk1?	N/A	N/A	Ramp inside XWalk2?	N/A
	Road Slope (%)	2.4		Clear Space?	N/A
	Road X Slope (%)	5.4	N/A	Clear Space to XWalk (in)	N/A
N/A	Any Obstructions?	N/A	N/A	Storm Grate/Utility Hazard?	N/A
	Obstruction Type			Storm Grate/Utility Type	
		N/A			N/A
			Yes	Surface Condition? (G/P)	Good
			No	Curb Slope (%)	5.9

Possible Solutions:

Remove & Replace Curb Ramp With Two New Directional Ramps or Equivalent.
