Access Compliance Report

Public Rights-of-Way

(Curb Ramps)

Intersection ID: 17092	Main Street: IRBY_DR	Cross Street: JAMESTON_DR	Location: NW
ADA ID: E93EB1433474	Ramp Type: BlendTrans2	Initial Pass/Fail: Fail	Overall Compliance: No
		Severity Score: 8.75

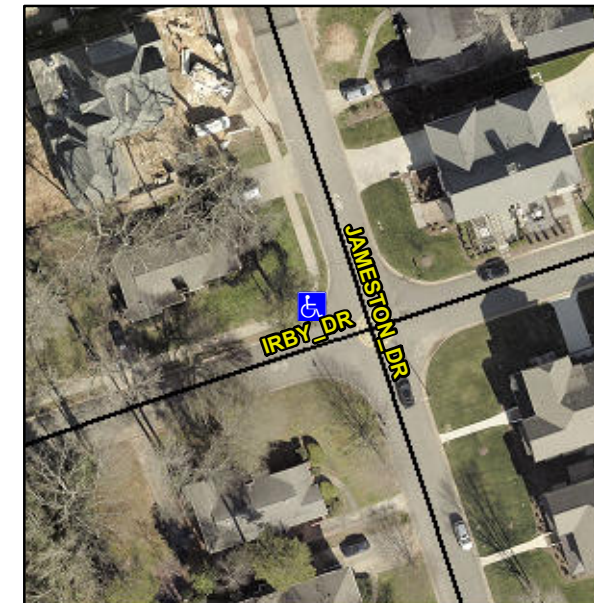
Compliance	Description	Data	Compliance	Description	Data
N/A	Ramp Length (in)	118.0	Yes	BlendTrans Slope (%)	3.1
No	Ramp Width (in)	46.0	Yes	BlendTrans XSlope (%)	1.9
N/A	Flare Type LT	N/A	N/A	Flare Type RT	N/A
N/A	Flare Slope LT (%)	N/A	N/A	Flare Slope RT (%)	N/A
N/A	Flare Traversable LT?	N/A	N/A	Flare Traversable RT?	N/A
N/A	Landing Length (in)	N/A	N/A	DWS Provided?	N/A
N/A	Landing Width (in)	N/A	N/A	DWS Contrast?	N/A
N/A	Landing Slope (%)	N/A	N/A	DWS Length (in)	N/A
N/A	Landing X Slope (%)	N/A	N/A	DWS Full Width?	N/A
N/A	Landing Curb? (Y/N)	N/A	N/A	DWS Offset (in)	N/A
N/A	Shared Landing?	N/A			
N/A	Gutter Ponding?	N/A	N/A	Gutter Slope (%)	N/A
N/A	Gutter Lip Ht (in)	N/A	N/A	Gutter X Slope (%)	N/A
N/A	Painted X Walk1?	No	N/A	Painted X Walk2?	No
	X Walk 1 Direction	To SE		X Walk 2 Direction	To NE
	X Walk 1 Width (in)	N/A		X Walk 2 Width (in)	N/A
	X Walk 1 Slope (%)	6.1		X Walk 2 Slope (%)	0.2
	X Walk 1 X Slope (%)	0.9		X Walk 2 X Slope (%)	7.4

N/A	Ramp inside XWalk1?	N/A	N/A	Ramp inside XWalk2?	N/A
	Road Slope (%)	2.2		Clear Space?	N/A
	Road X Slope (%)	5.4	N/A	Clear Space to XWalk (in)	N/A
N/A	Any Obstructions?	N/A	N/A	Storm Grate/Utility Hazard?	N/A
	Obstruction Type			Storm Grate/Utility Type	
		N/A			N/A
			Yes	Surface Condition? (G/P)	Good
			No	Curb Slope (%)	12.4

Remove & Replace Curb Ramp With Two New Directional Ramps or Equivalent.

Not Found, R304.5.1
