# Access Compliance Report

## Public Rights-of-Way

### (Curb Ramps)

Intersection ID: 10033071	Main Street: NORTH_COMMUNITY_HOUSE_RD	Cross Street: N/A	Location: SW
ADA ID: E941219ED651	Ramp Type: Para	Initial Pass/Fail: Fail	Overall Compliance: No
Severity Score: 13.75			
Codes/Mitigation Info/Possible Solution		Field Measurements/Component Compliance

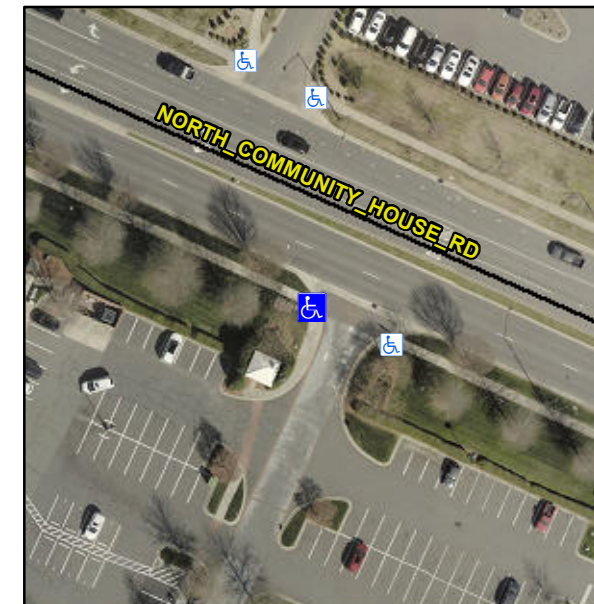
Surveyor Notes:

**RT RP < 5%**

PROW/ADA:

**R304.3.2, R304.5.3**

Compliance	Description	Data	Compliance	Description	Data
N/A	Ramp Length LT (in)	77.0	N/A	Ramp Length RT (in)	71.0
Yes	Ramp Width LT (in)	60.0	Yes	Ramp Width RT (in)	58.0
No	Ramp Slope LT (%)	10.3	Yes	Ramp Slope RT (%)	1.4
No	Ramp XSlope LT (%)	2.1	No	Ramp XSlope RT (%)	4.7
N/A	Landing Length (in)	N/A	N/A	DWS Provided?	N/A
N/A	Landing Width (in)	N/A	N/A	DWS Contrast?	N/A
N/A	Landing Slope (%)	N/A	N/A	DWS Length (in)	N/A
N/A	Landing X Slope (%)	N/A	N/A	DWS Full Width?	N/A
N/A	Landing Curb? (Y/N)	N/A	N/A	DWS Offset (in)	N/A
N/A	Shared Landing?	N/A			
N/A	Gutter Ponding?	N/A	N/A	Gutter Slope (%)	N/A
N/A	Gutter Lip Ht (in)	N/A	N/A	Gutter X Slope (%)	N/A
N/A	Painted X Walk1?	No	N/A	Painted X Walk2?	N/A
	X Walk 1 Direction	To SE		X Walk 2 Direction	N/A
N/A	X Walk 1 Width (in)	N/A	N/A	X Walk 2 Width (in)	N/A
	X Walk 1 Slope (%)	4.3		X Walk 2 Slope (%)	N/A
	X Walk 1 X Slope (%)	2.2		X Walk 2 X Slope (%)	N/A
N/A	Ramp inside XWalk1?	N/A	N/A	Ramp inside XWalk2?	N/A

Road Slope (%)	N/A	N/A	Clear Space?	N/A
	Road X Slope (%)	N/A	N/A	Clear Space to XWalk (in)	N/A
N/A	Any Obstructions?	N/A	N/A	Storm Grate/Utility Hazard?	N/A
	Obstruction Type			Storm Grate/Utility Type	
		N/A			N/A
			Yes	Surface Condition? (G/P)	Good
			N/A	Curb Slope (%)	9.3

Possible Solutions:

**Remove & Replace Entire Ramp.**
