# Access Compliance Report

## Public Rights-of-Way

### (Curb Ramps)

| Intersection ID: 23967 | Main Street: AILEEN_CR | Cross Street: CHINA GROVE CHURCH_RD | Location: SE |

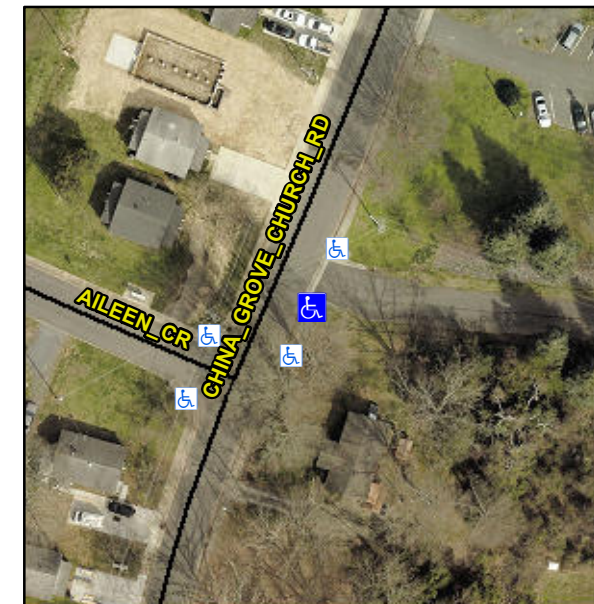
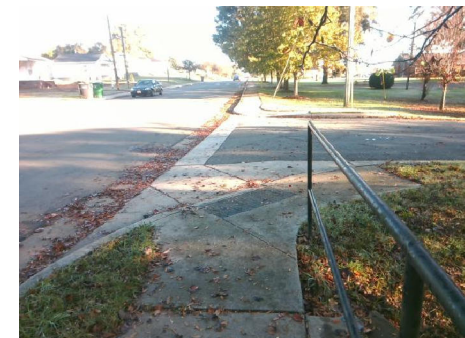
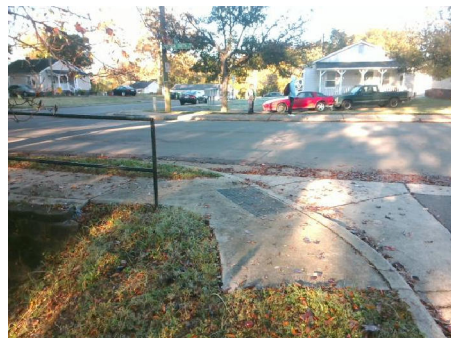
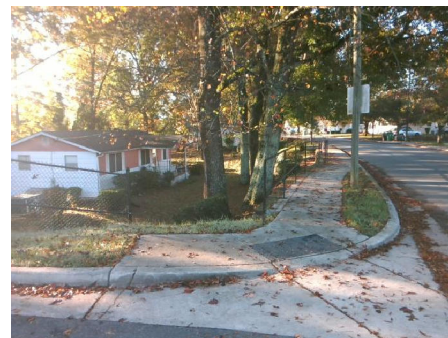
| ADA ID: E95204E4029C | Ramp Type: BlendTrans2 | Initial Pass/Fail: Pass | Overall Compliance: No |

**Not Found, R304.2.3, R304.5.3**

| Compliance | Description | Data | Compliance | Description | Data |
|---|---|---|---|---|---|
| N/A | Flare Slope LT (%) | N/A | No | Flare Slope RT (%) | N/A |
| Yes | Gutter Lip Ht (in) | 0.0 | No | Gutter X Slope (%) | 2.4 |
| | | | No | Curb Slope (%) | 21.2 |

**Remove & Replace Curb Ramp With Two New Directional Ramps or Equivalent. Remove & Replace Gutter.**

Total Cost: \$ 3950.00
