Access Compliance Report

Public Rights-of-Way

(Curb Ramps)

Intersection ID: 10033787	Main Street: PACIFIC_ECHO_DR	Cross Street: N/A	Location: SE
ADA ID: E952DB240216	Ramp Type: Perp	Initial Pass/Fail: Fail	Overall Compliance: No
Severity Score: 12.5			
Codes/Mitigation Info/Possible Solution		Field Measurements/Component Compliance

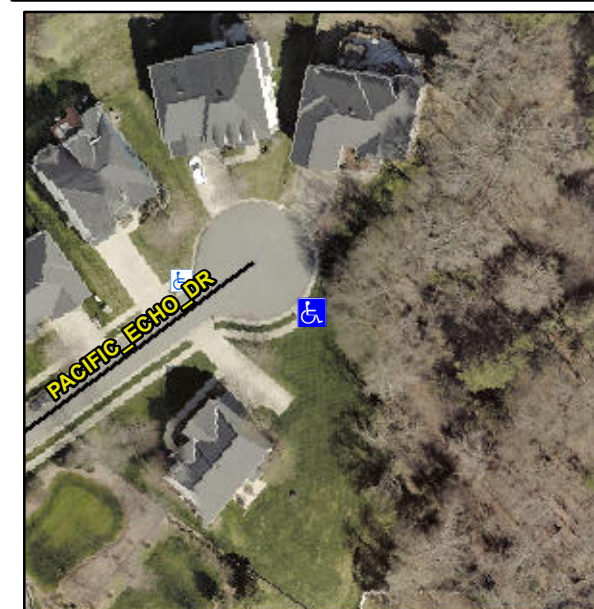
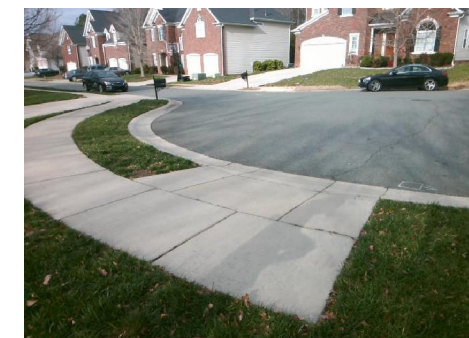
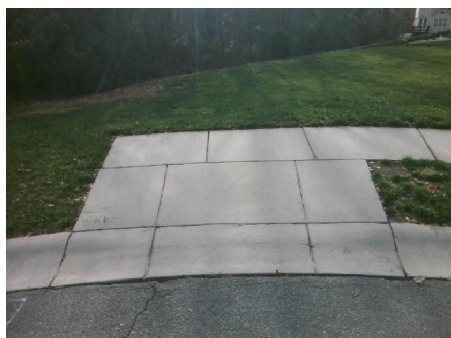
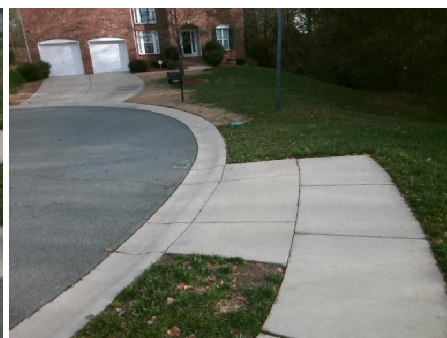
Not Found, R304.2.2

Compliance	Description	Data	Compliance	Description	Data
N/A	Ramp Length (in)	47.0	No	Ramp Slope (%)	8.9
Yes	Ramp Width (in)	59.0	Yes	Ramp XSlope (%)	1.9
N/A	Flare Type LT	N/A	N/A	Flare Type RT	N/A
N/A	Flare Slope LT (%)	N/A	N/A	Flare Slope RT (%)	N/A
N/A	Flare Traversable LT?	N/A	N/A	Flare Traversable RT?	N/A
N/A	Landing Length (in)	N/A	N/A	DWS Provided?	N/A
N/A	Landing Width (in)	N/A	N/A	DWS Contrast?	N/A
N/A	Landing Slope (%)	N/A	N/A	DWS Length (in)	N/A
N/A	Landing X Slope (%)	N/A	N/A	DWS Full Width?	N/A
N/A	Landing Curb? (Y/N)	N/A	N/A	DWS Offset (in)	N/A
N/A	Shared Landing?	N/A			
N/A	Gutter Ponding?	N/A	N/A	Gutter Slope (%)	N/A
N/A	Gutter Lip Ht (in)	N/A	N/A	Gutter X Slope (%)	N/A
N/A	Painted X Walk1?	No	N/A	Painted X Walk2?	N/A
	X Walk 1 Direction	To NW		X Walk 2 Direction	N/A
N/A	X Walk 1 Width (in)	N/A	N/A	X Walk 2 Width (in)	N/A
	X Walk 1 Slope (%)	3.8		X Walk 2 Slope (%)	N/A
	X Walk 1 X Slope (%)	1.2		X Walk 2 X Slope (%)	N/A

Possible Solutions:

Remove & Replace Entire Ramp.
