Access Compliance Report Public Rights-of-Way (Curb Ramps)

Intersection ID: 5808	Main Street: FOREST_POND_DR	Cross Street: NEVIN_RD	Location: SE
ADA ID: E952EDFBA2CF	Ramp Type: Perp	Initial Pass/Fail: Fail	Overall Compliance: No Severity Score: 1.25

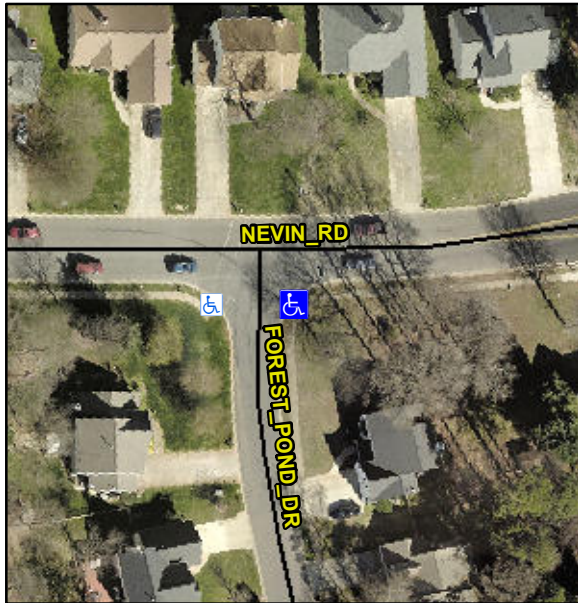
Not Found, R304.5.3

Compliance	Description	Data	Compliance	Description	Data
N/A	Ramp Length (in)	47.0	Yes	Ramp Slope (%)	8.1
Yes	Ramp Width (in)	48.0	No	Ramp XSlope (%)	3.9
N/A	Flare Type LT	N/A	N/A	Flare Type RT	N/A
N/A	Flare Slope LT (%)	N/A	N/A	Flare Slope RT (%)	N/A
N/A	Flare Traversable LT?	N/A	N/A	Flare Traversable RT?	N/A
N/A	Landing Length (in)	N/A	N/A	DWS Provided?	N/A
N/A	Landing Width (in)	N/A	N/A	DWS Contrast?	N/A
N/A	Landing Slope (%)	N/A	N/A	DWS Length (in)	N/A
N/A	Landing X Slope (%)	N/A	N/A	DWS Full Width?	N/A
N/A	Landing Curb? (Y/N)	N/A	N/A	DWS Offset (in)	N/A
N/A	Shared Landing?	N/A			
N/A	Gutter Ponding?	N/A	N/A	Gutter Slope (%)	N/A
N/A	Gutter Lip Ht (in)	N/A	N/A	Gutter X Slope (%)	N/A
N/A	Painted X Walk1?	No	N/A	Painted X Walk2?	N/A
	X Walk 1 Direction	To W		X Walk 2 Direction	N/A
N/A	X Walk 1 Width (in)	N/A	N/A	X Walk 2 Width (in)	N/A
	X Walk 1 Slope (%)	2.6		X Walk 2 Slope (%)	N/A
	X Walk 1 X Slope (%)	4.4		X Walk 2 X Slope (%)	N/A

N/A	Ramp inside XWalk1?	N/A	N/A	Ramp inside XWalk2?	N/A
	Road Slope (%)	N/A	N/A	Clear Space?	N/A
	Road X Slope (%)	N/A	N/A	Clear Space to XWalk (in)	N/A
N/A	Any Obstructions?	N/A	N/A	Storm Grate/Utility Hazard?	N/A
	Obstruction Type			Storm Grate/Utility Type	
			N/A		N/A
			Yes	Surface Condition? (G/P)	Good

Remove & Replace Entire Ramp.
