Access Compliance Report

Public Rights-of-Way

(Curb Ramps)

Intersection ID: 19985	Main Street: CHITAL_RD	Cross Street: FALLOW_LN	Location: NE
ADA ID: E953C48F9E93	Ramp Type: PerpDiag	Initial Pass/Fail: Fail	Overall Compliance: No
Severity Score: 0			
Codes/Mitigation Info/Possible Solution		Field Measurements/Component Compliance

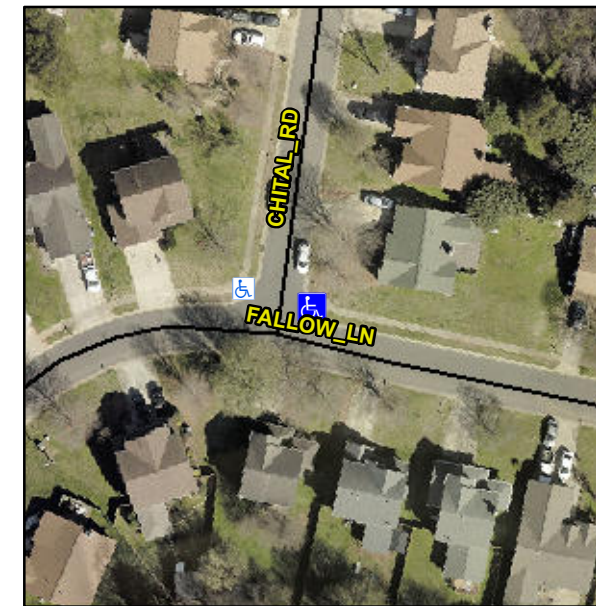
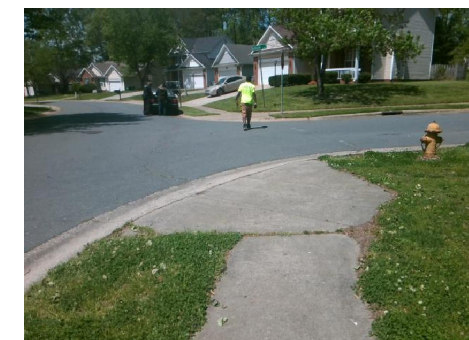
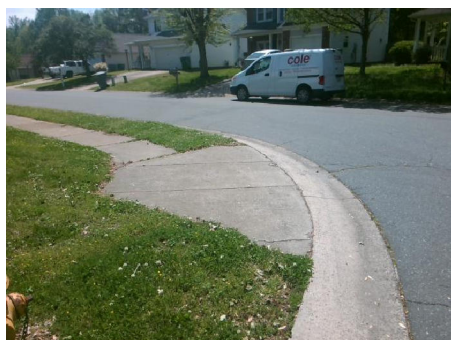
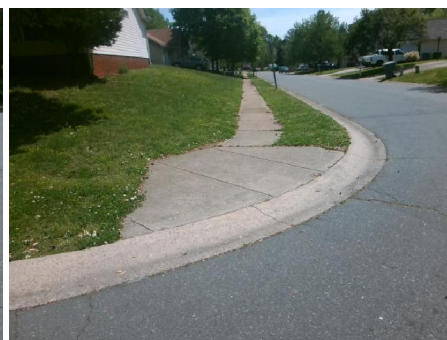
Compliance	Description	Data	Compliance	Description	Data
N/A	Ramp Length (in)	96.0	Yes	Ramp Slope (%)	5.4
Yes	Ramp Width (in)	48.0	Yes	Ramp XSlope (%)	1.1
N/A	Flare Type LT	N/A	N/A	Flare Type RT	N/A
N/A	Flare Slope LT (%)	N/A	N/A	Flare Slope RT (%)	N/A
N/A	Flare Traversable LT?	N/A	N/A	Flare Traversable RT?	N/A
N/A	Landing Length (in)	N/A	N/A	DWS Provided?	N/A
N/A	Landing Width (in)	N/A	N/A	DWS Contrast?	N/A
N/A	Landing Slope (%)	N/A	N/A	DWS Length (in)	N/A
N/A	Landing X Slope (%)	N/A	N/A	DWS Full Width?	N/A
N/A	Landing Curb? (Y/N)	N/A	N/A	DWS Offset (in)	N/A
N/A	Shared Landing?	N/A			
N/A	Gutter Ponding?	N/A	N/A	Gutter Slope (%)	N/A
N/A	Gutter Lip Ht (in)	N/A	N/A	Gutter X Slope (%)	N/A
N/A	Painted X Walk1?	No	N/A	Painted X Walk2?	No
	X Walk 1 Direction	To W		X Walk 2 Direction	To S
N/A	X Walk 1 Width (in)	N/A	N/A	X Walk 2 Width (in)	N/A
	X Walk 1 Slope (%)	1.2		X Walk 2 Slope (%)	2.3
	X Walk 1 X Slope (%)	0.3		X Walk 2 X Slope (%)	2.0

N/A	Ramp inside XWalk1?	N/A	N/A	Ramp inside XWalk2?	N/A
	Road Slope (%)	0.9	N/A	Clear Space?	N/A
	Road X Slope (%)	2.1	N/A	Clear Space to XWalk (in)	N/A
N/A	Any Obstructions?	N/A	N/A	Storm Grate/Utility Hazard?	N/A
	Obstruction Type			Storm Grate/Utility Type	
		N/A			N/A
		Yes		Surface Condition? (G/P)	Good

Remove & Replace Curb Ramp With Two New Directional Ramps or Equivalent.
