Access Compliance Report Public Rights-of-Way (Curb Ramps)

Intersection ID: 18654 Main	Main Street: ESTATES_AV		Cross Street: PARK_RD				NW
ADA ID: E965F5F81FAC Ramp	Ramp Type: PerpDiag		Initial Pass/Fail: Fail Overall Compliance: No			o Severity Score:	17.5
Codes/Mitigation Info/Possible Solution		Field Measurements/Component Compliance					
	Possible Solutions:	Con	Compliance Description Data		Compliance Description		Data
ESTATES AV	Remove & Replace Curb Ramp W	ith N/A	Ramp Length (ir	n) 107.0	Yes	Ramp Slope (%)	7.1
	Two New Directional Ramps or	No	Ramp Width (in)) 32.0	Yes	Ramp XSlope (%)	1.2
	Equivalent.	N/A	Flare Type LT	N/A	N/A	Flare Type RT	N/A
		N/A	Flare Slope LT ((%) N/A	N/A	Flare Slope RT (%)	N/A
		N/A	Flare Traversab	le LT? N/A	N/A	Flare Traversable RT?	N/A
		N/A	Landing Length	(in) N/A	N/A	DWS Provided?	N/A
	Surveyor Notes:	N/A	Landing Width (i	in) N/A	N/A	DWS Contrast?	N/A
	N/A	N/A	Landing Slope (%) N/A	N/A	DWS Length (in)	N/A
		N/A	Landing X Slope	e (%) N/A	N/A	DWS Full Width?	N/A

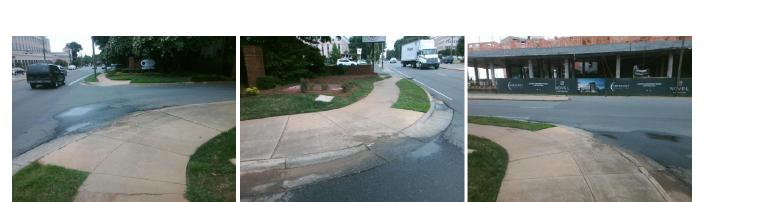
6. P	Ě.	N/A	Landing Curb? ((Y/N) N/A	N/A	DWS Offset (in)	N/A
The second s		N/A	Shared Landing	? N/A			
A second at 19	PROW/ADA:	N/A	Gutter Ponding	? N/A	N/A	Gutter Slope (%)	N/A
	Not Found, R304.5.1	N/A	Gutter Lip Ht (in	n) N/A	N/A	Gutter X Slope (%)	N/A
		N/A	Painted X Walk1	,	N/A	Painted X Walk2?	No
			X Walk 1 Directi	ion To S		X Walk 2 Direction	To E
		N/A	X Walk 1 Width	(in) N/A	N/A	X Walk 2 Width (in)	N/A
Street 1 Name ESTATES A	 /		X Walk 1 Slope	(%) 0.5		X Walk 2 Slope (%)	1.9
Stop Condition-Street 2 StopSig	n		X Walk 1 X Slop	oe (%) 0.5		X Walk 2 X Slope (%)	0.7
Street 2 Name PARK R	0	N/A	Ramp inside XV	Valk1? N/A	N/A	Ramp inside XWalk2?	N/A
Stop Condition-Street 1 Non	9		Road Slope (%)	0.0	N/A	Clear Space?	N/A

•			Road X Slope (%		N/A	Clear Space to XWalk (in)	N/A
		N/A	• •	,	N/A	Storm Grate/Utility Hazard?	N/A
	Total Cost: \$ 32	00.00	Obstruction Typ			Storm Grate/Utility Type	
			21	N/A			N/A
