Access Compliance Report

Public Rights-of-Way

(Curb Ramps)

Intersection ID: 43164	Main Street: N_GRAHAM_ST	Cross Street: ONEIDA_RD	Location: S
ADA ID: E96CBD26207A	Ramp Type: Perp	Initial Pass/Fail: Fail	Overall Compliance: No
Severity Score: 21.25			
Codes/Mitigation Info/Possible Solution		Field Measurements/Component Compliance

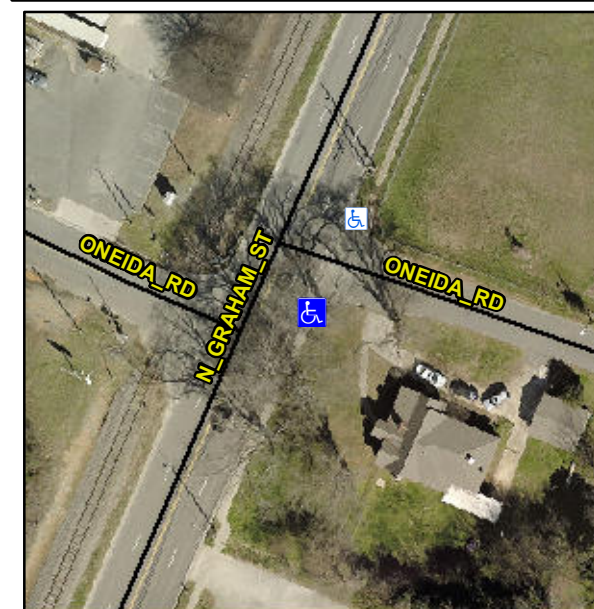
Not Found, R304.5.1, R304.2.2

Compliance	Description	Data	Compliance	Description	Data
N/A	Ramp Length (in)	60.0	No	Ramp Slope (%)	8.4
No	Ramp Width (in)	45.5	Yes	Ramp XSlope (%)	1.3
N/A	Flare Type LT	N/A	N/A	Flare Type RT	N/A
N/A	Flare Slope LT (%)	N/A	N/A	Flare Slope RT (%)	N/A
N/A	Flare Traversable LT?	N/A	N/A	Flare Traversable RT?	N/A
N/A	Landing Length (in)	N/A	N/A	DWS Provided?	N/A
N/A	Landing Width (in)	N/A	N/A	DWS Contrast?	N/A
N/A	Landing Slope (%)	N/A	N/A	DWS Length (in)	N/A
N/A	Landing X Slope (%)	N/A	N/A	DWS Full Width?	N/A
N/A	Landing Curb? (Y/N)	N/A	N/A	DWS Offset (in)	N/A
N/A	Shared Landing?	N/A			
N/A	Gutter Ponding?	N/A	N/A	Gutter Slope (%)	N/A
N/A	Gutter Lip Ht (in)	1.5	N/A	Gutter X Slope (%)	N/A
N/A	Painted X Walk1?	No	N/A	Painted X Walk2?	N/A
	X Walk 1 Direction	To NE		X Walk 2 Direction	N/A
N/A	X Walk 1 Width (in)	N/A	N/A	X Walk 2 Width (in)	N/A
	X Walk 1 Slope (%)	1.3		X Walk 2 Slope (%)	N/A
	X Walk 1 X Slope (%)	0.3		X Walk 2 X Slope (%)	N/A

N/A	Ramp inside XWalk1?	N/A	N/A	Ramp inside XWalk2?	N/A
	Road Slope (%)	N/A	N/A	Clear Space?	N/A
	Road X Slope (%)	N/A	N/A	Clear Space to XWalk (in)	N/A
N/A	Any Obstructions?	N/A	N/A	Storm Grate/Utility Hazard?	N/A
	Obstruction Type			Storm Grate/Utility Type	
		N/A			N/A
			Yes	Surface Condition? (G/P)	Good

Possible Solutions:

Remove & Replace Entire Ramp.

Total Cost: \$ 1850.00
