Access Compliance Report

Public Rights-of-Way

(Curb Ramps)

Intersection ID: 28231	Main Street: AUTUMN_APPLAUSE_DR	Cross Street: FIELDCROFT_DR	Location: NW
ADA ID: E96D04EB90C2	Ramp Type: PerpDiag	Initial Pass/Fail: Fail	Overall Compliance: No
		Severity Score: 17.5

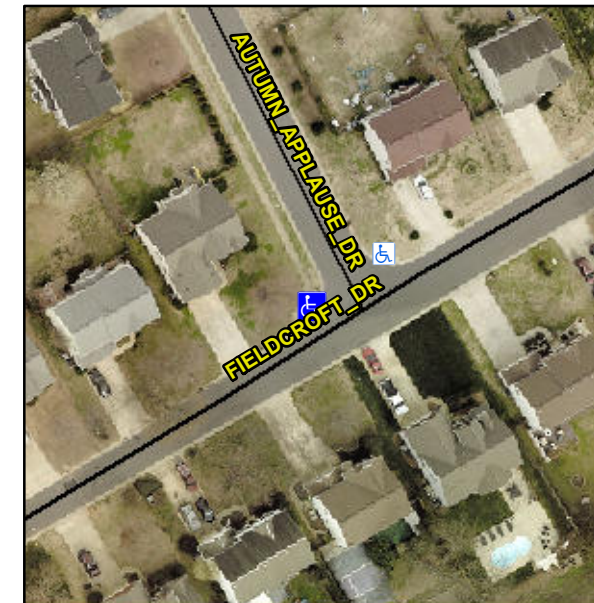
Not Found, R304.5.1

Compliance	Description	Data	Compliance	Description	Data
N/A	Ramp Length (in)	98.0	Yes	Ramp Slope (%)	8.1
No	Ramp Width (in)	34.0	Yes	Ramp XSlope (%)	0.5
N/A	Flare Type LT	N/A	N/A	Flare Type RT	N/A
N/A	Flare Slope LT (%)	N/A	N/A	Flare Slope RT (%)	N/A
N/A	Flare Traversable LT?	N/A	N/A	Flare Traversable RT?	N/A
N/A	Landing Length (in)	N/A	N/A	DWS Provided?	N/A
N/A	Landing Width (in)	N/A	N/A	DWS Contrast?	N/A
N/A	Landing Slope (%)	N/A	N/A	DWS Length (in)	N/A
N/A	Landing X Slope (%)	N/A	N/A	DWS Full Width?	N/A
N/A	Landing Curb? (Y/N)	N/A	N/A	DWS Offset (in)	N/A
N/A	Shared Landing?	N/A			
N/A	Gutter Ponding?	N/A	N/A	Gutter Slope (%)	N/A
N/A	Gutter Lip Ht (in)	N/A	N/A	Gutter X Slope (%)	N/A
N/A	Painted X Walk1?	No	N/A	Painted X Walk2?	No
	X Walk 1 Direction	To SE		X Walk 2 Direction	To NE
N/A	X Walk 1 Width (in)	N/A	N/A	X Walk 2 Width (in)	N/A
	X Walk 1 Slope (%)	2.3		X Walk 2 Slope (%)	2.2
	X Walk 1 X Slope (%)	1.3		X Walk 2 X Slope (%)	0.1

N/A	Ramp inside XWalk1?	N/A	N/A	Ramp inside XWalk2?	N/A
	Road Slope (%)	2.8	N/A	Clear Space?	N/A
	Road X Slope (%)	1.5	N/A	Clear Space to XWalk (in)	N/A
N/A	Any Obstructions?	N/A	N/A	Storm Grate/Utility Hazard?	N/A
	Obstruction Type			Storm Grate/Utility Type	
		N/A			N/A
			Yes	Surface Condition? (G/P)	Good

Remove & Replace Curb Ramp With Two New Directional Ramps or Equivalent.

Total Cost: \$ 3200.00
