Access Compliance Report

Public Rights-of-Way

(Curb Ramps)

Intersection ID: 14879	Main Street: ROSEHAVEN_DR	Cross Street: WINTERFIELD_PL	Location: NE
ADA ID: E97B41A7FA41	Ramp Type: PerpDiag	Initial Pass/Fail: Fail	Overall Compliance: No
			Severity Score: 33.75

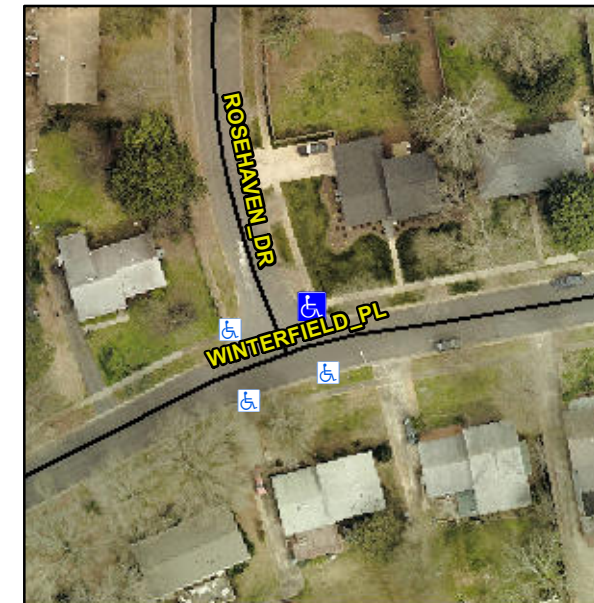
Not Found, R304.5.1, R304.5.3

Compliance	Description	Data	Compliance	Description	Data
N/A	Ramp Length (in)	73.5	Yes	Ramp Slope (%)	5.2
No	Ramp Width (in)	46.0	No	Ramp XSlope (%)	7.9
N/A	Flare Type LT	N/A	N/A	Flare Type RT	N/A
N/A	Flare Slope LT (%)	N/A	N/A	Flare Slope RT (%)	N/A
N/A	Flare Traversable LT?	N/A	N/A	Flare Traversable RT?	N/A
N/A	Landing Length (in)	N/A	N/A	DWS Provided?	N/A
N/A	Landing Width (in)	N/A	N/A	DWS Contrast?	N/A
N/A	Landing Slope (%)	N/A	N/A	DWS Length (in)	N/A
N/A	Landing X Slope (%)	N/A	N/A	DWS Full Width?	N/A
N/A	Landing Curb? (Y/N)	N/A	N/A	DWS Offset (in)	N/A
N/A	Shared Landing?	N/A			
N/A	Gutter Ponding?	N/A	N/A	Gutter Slope (%)	N/A
N/A	Gutter Lip Ht (in)	N/A	N/A	Gutter X Slope (%)	N/A
N/A	Painted X Walk1?	No	N/A	Painted X Walk2?	No
	X Walk 1 Direction	To W		X Walk 2 Direction	To S
N/A	X Walk 1 Width (in)	N/A	N/A	X Walk 2 Width (in)	N/A
	X Walk 1 Slope (%)	5.2		X Walk 2 Slope (%)	3.5
	X Walk 1 X Slope (%)	5.3		X Walk 2 X Slope (%)	6.3

N/A	Ramp inside XWalk1?	N/A	N/A	Ramp inside XWalk2?	N/A
	Road Slope (%)	8.4	N/A	Clear Space?	N/A
	Road X Slope (%)	2.9	N/A	Clear Space to XWalk (in)	N/A
N/A	Any Obstructions?	N/A	N/A	Storm Grate/Utility Hazard?	N/A
	Obstruction Type			Storm Grate/Utility Type	
		N/A			N/A
			Yes	Surface Condition? (G/P)	Good

Remove & Replace Curb Ramp With Two New Directional Ramps or Equivalent.
