Access Compliance Report

Public Rights-of-Way

(Curb Ramps)

Intersection ID: 10027984	Main Street: HARLINGTON_LN	Cross Street: N/A	Location: SW
ADA ID: E97B57359494	Ramp Type: BlendTrans1	Initial Pass/Fail: Fail	Overall Compliance: No
			Severity Score: 8.75
Codes/Mitigation Info/Possible Solution		Field Measurements/Component Compliance

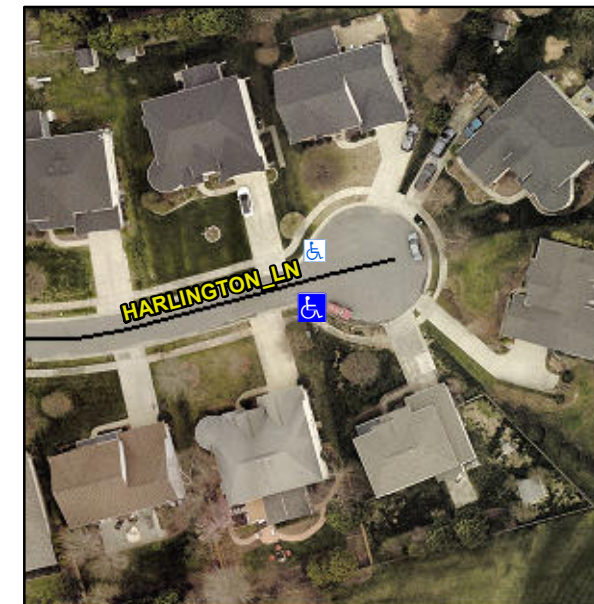
Not Found, R304.5.1

Compliance	Description	Data	Compliance	Description	Data
N/A	Ramp Length (in)	50.0	Yes	BlendTrans Slope (%)	3.5
No	Ramp Width (in)	47.5	Yes	BlendTrans XSlope (%)	2.0
N/A	Flare Type LT	N/A	N/A	Flare Type RT	N/A
N/A	Flare Slope LT (%)	N/A	N/A	Flare Slope RT (%)	N/A
N/A	Flare Traversable LT?	N/A	N/A	Flare Traversable RT?	N/A
N/A	Landing Length (in)	N/A	N/A	DWS Provided?	N/A
N/A	Landing Width (in)	N/A	N/A	DWS Contrast?	N/A
N/A	Landing Slope (%)	N/A	N/A	DWS Length (in)	N/A
N/A	Landing X Slope (%)	N/A	N/A	DWS Full Width?	N/A
N/A	Landing Curb? (Y/N)	N/A	N/A	DWS Offset (in)	N/A
N/A	Shared Landing?	N/A			
N/A	Gutter Ponding?	N/A	N/A	Gutter Slope (%)	N/A
N/A	Gutter Lip Ht (in)	N/A	N/A	Gutter X Slope (%)	N/A
N/A	Painted X Walk1?	No	N/A	Painted X Walk2?	N/A
	X Walk 1 Direction	To N		X Walk 2 Direction	N/A
	X Walk 1 Width (in)	N/A		X Walk 2 Width (in)	N/A
	X Walk 1 Slope (%)	2.3		X Walk 2 Slope (%)	N/A
	X Walk 1 X Slope (%)	2.4		X Walk 2 X Slope (%)	N/A

N/A	Ramp inside XWalk1?	N/A	N/A	Ramp inside XWalk2?	N/A
	Road Slope (%)	2.4		Clear Space?	N/A
	Road X Slope (%)	2.3	N/A	Clear Space to XWalk (in)	N/A
N/A	Any Obstructions?	N/A	N/A	Storm Grate/Utility Hazard?	N/A
	Obstruction Type			Storm Grate/Utility Type	
		N/A			N/A
			Yes	Surface Condition? (G/P)	Good
			No	Curb Slope (%)	13.4

Possible Solutions:

Remove & Replace Curb Ramp With Two New Directional Ramps or Equivalent.

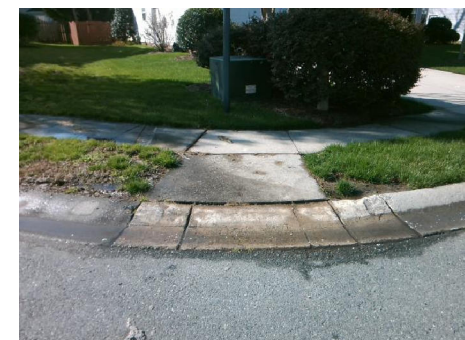
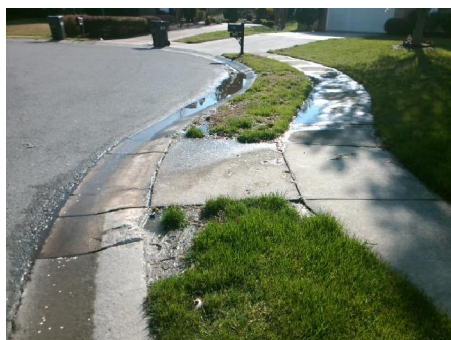
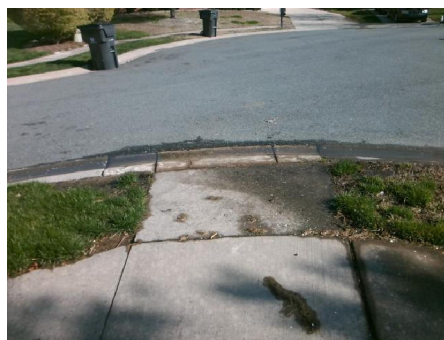
Street 1 Name	HARLINGTON LN
Stop Condition-Street 1	None
Street 2 Name	N/A
Stop Condition-Street 2	N/A
