# Access Compliance Report

## Public Rights-of-Way

### (Curb Ramps)

Intersection ID: 29758	Main Street: BALLANTYNE COMMONS PY	Cross Street: WILLIAMS POND LN	Location: SW
ADA ID: E981392D6E3C	Ramp Type: MedianPerp	Initial Pass/Fail: Fail	Overall Compliance: No
Severity Score: 12.5			
Codes/Mitigation Info/Possible Solution		Field Measurements/Component Compliance

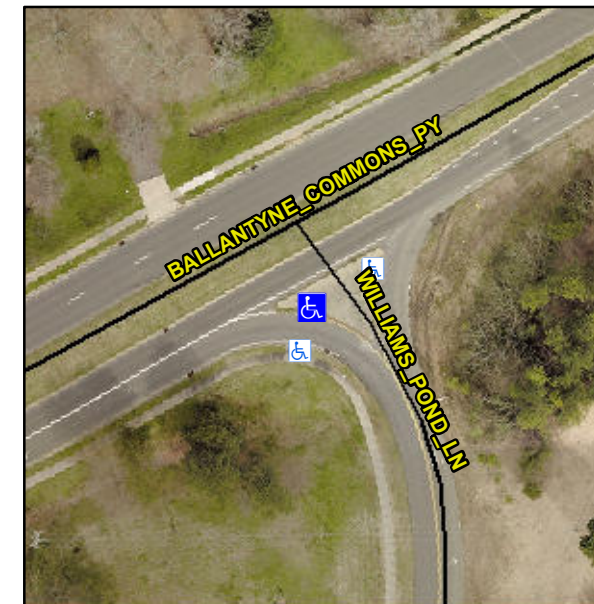
Compliance	Description	Data	Compliance	Description	Data
N/A	Ramp Length (in)	54.0	No	Ramp Slope (%)	9.0
Yes	Ramp Width (in)	48.0	Yes	Ramp XSlope (%)	0.0
N/A	Flare Type LT	N/A	N/A	Flare Type RT	N/A
N/A	Flare Slope LT (%)	N/A	N/A	Flare Slope RT (%)	N/A
N/A	Flare Traversable LT?	N/A	N/A	Flare Traversable RT?	N/A
N/A	Landing Length (in)	N/A	N/A	DWS Provided?	N/A
N/A	Landing Width (in)	N/A	N/A	DWS Contrast?	N/A
N/A	Landing Slope (%)	N/A	N/A	DWS Length (in)	N/A
N/A	Landing X Slope (%)	N/A	N/A	DWS Full Width?	N/A
N/A	Landing Curb? (Y/N)	N/A	N/A	DWS Offset (in)	N/A
N/A	Shared Landing?	N/A			
N/A	Gutter Ponding?	N/A	N/A	Gutter Slope (%)	N/A
N/A	Gutter Lip Ht (in)	N/A	N/A	Gutter X Slope (%)	N/A
N/A	Painted X Walk1?	No	N/A	Painted X Walk2?	N/A
	X Walk 1 Direction	To SW		X Walk 2 Direction	N/A
N/A	X Walk 1 Width (in)	N/A	N/A	X Walk 2 Width (in)	N/A
	X Walk 1 Slope (%)	0.8		X Walk 2 Slope (%)	N/A
	X Walk 1 X Slope (%)	2.8		X Walk 2 X Slope (%)	N/A

N/A	Ramp inside XWalk1?	N/A	N/A	Ramp inside XWalk2?	N/A
	Road Slope (%)	N/A	N/A	Clear Space?	N/A
	Road X Slope (%)	N/A	N/A	Clear Space to XWalk (in)	N/A
N/A	Any Obstructions?	N/A	N/A	Storm Grate/Utility Hazard?	N/A
	Obstruction Type			Storm Grate/Utility Type	
		N/A			N/A
		Yes		Surface Condition? (G/P)	Good

**Remove & Replace Entire Ramp.**

**R304.2.2**
